REPORT

Property surveyed XXXX

Thank you for instructing us to carry out a damp survey of XXXX. We understand that you own the house. That your buyer's surveyor flagged up some potential damp issues and that you wish to have an opinion from an independent expert damp surveyor. Please inform us if we have misunderstanding your instructions.

I confirm that I inspected XXXX on 13 April 2018. I conclude that at the time of the survey there was no significant risk of rising damp from below the original external ground level.

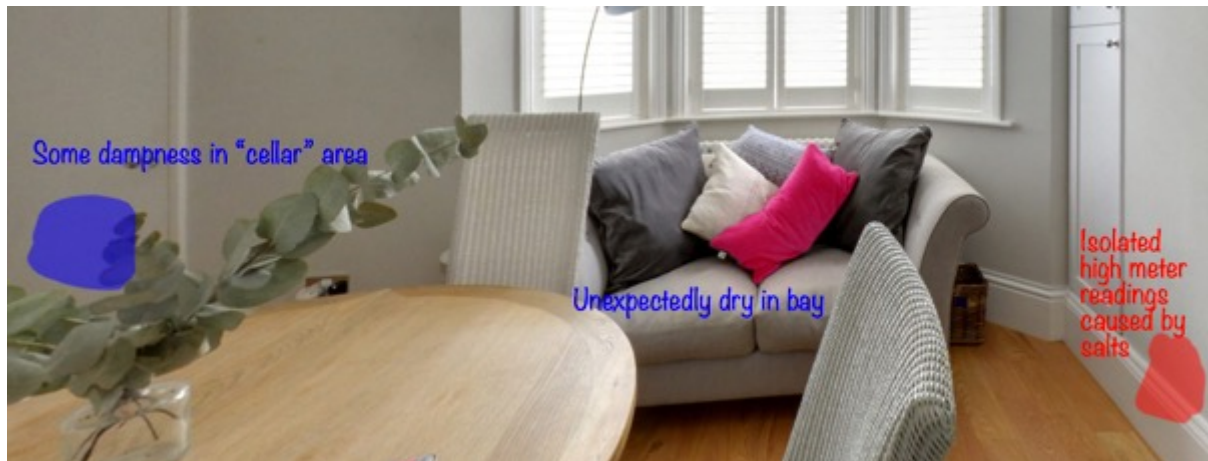
Front reception, the area needing further investigation is shown in red below

The high meter readings in the “dining room” are caused by salts. See explanation for why chimneys are normally high in salts; <https://www.youtube.com/watch?v=KuoKhF31hL8>.

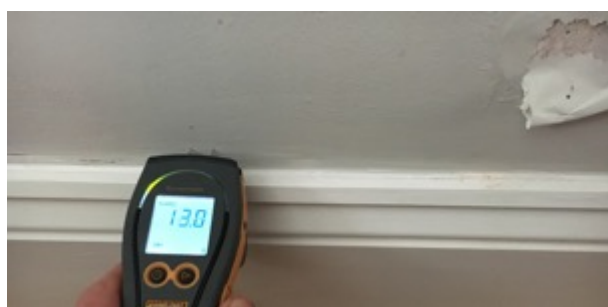
The left-hand image shows low damp meter reading of 13.0% WME. This demonstrates that rising damp is not present. Salt damage can be seen to the right (in the salt area the meter read 52%WME – see page 8). With rising damp, moisture is by definition greater, lower down a wall.

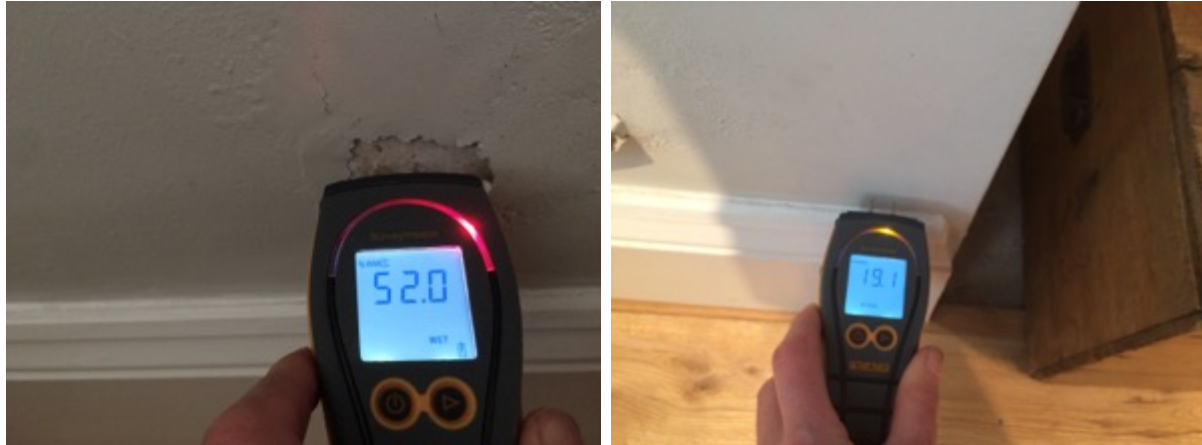
1 Elevated meter reading on chimney breast

The wall visibly suffering from salt damage, almost certainly calcium sulphate found in gypsum plaster, with salts from a time when wood or coal was burnt in the fireplace. These salts are hygroscopic (they attract water). Sulphate migrates and concentrate on the surface 1mm when plaster has been applied without time for successive layers to dry. As can be seen in the right-hand image the wall is dry a short distance away, at a lower position, this demonstrates that it can't be rising damp, as the effect of gravity ensures that lower pores in masonry are saturated first, before moisture will rise.

Use a coarse grain sandpaper to take away the first 1mm or so. Allow to dry thoroughly. Test with damp meter, a cheap £10 meter through shop or Amazon/eBay etc is sufficient for these purposes. If showing normal dampness, repaint, initially with 10:1 (paint to water) mist coat. The time to repair this is about 1hour in total.

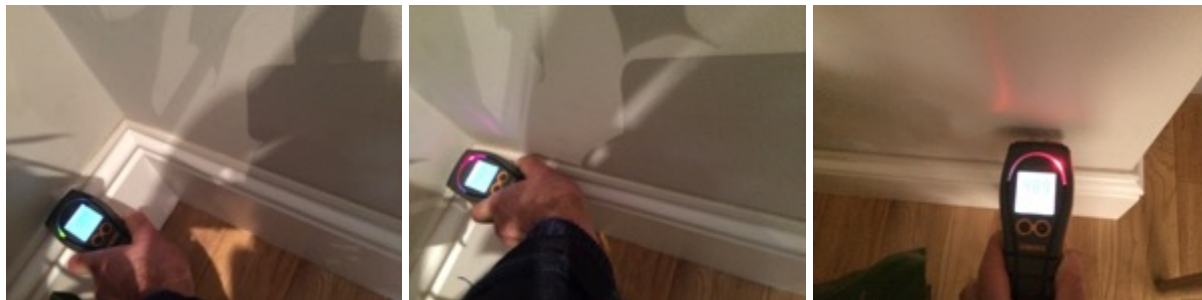
2 Elevated meter readings by the narrow wall to kitchen

The above shows damp meter readings by the narrow wall separating the kitchen from the dining room. The readings are from left to right 10.9%WME 40.5%WME, 48.9%WME. The area looks like it has been replastered, presumably when the kitchen was divided. The decorative paint does not look spoilt. However, excessive humidity (over 80%RH) may cause a temporary and slight discoloration.

The solid floors are unlikely to contain a damp-proof membrane to stop rising damp. However, timber were sampled teste. None were found to have high damp meter readings, which they would have if they were in contact with damp earth.

The effect of the salts are probably too marginal to do anything with this area. However, if damp appears, do the same as 1 above. Similar time to repair.

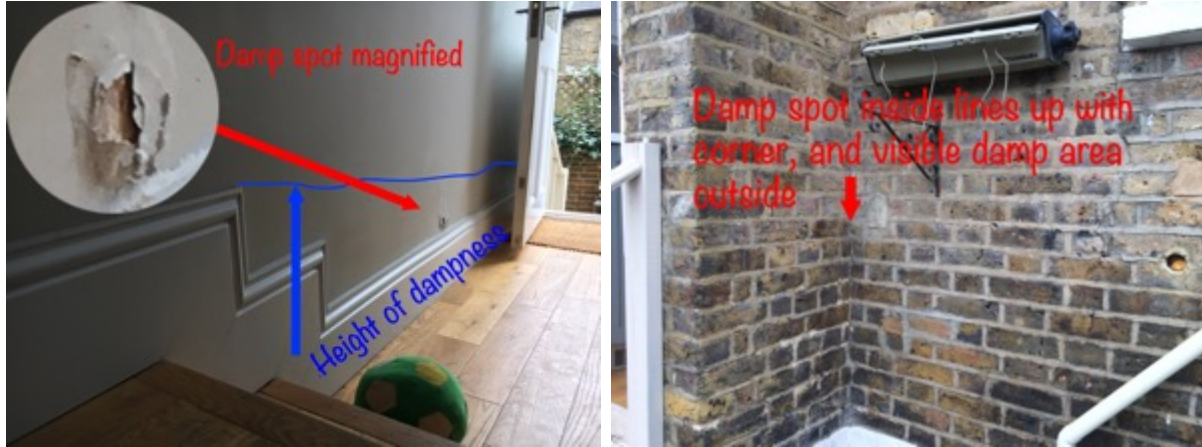
3 Water damaged plaster in corridor by door to back garden

The most significant moisture in the house is in the corridor by the back door. The dampness lines up with dampness found on the outside of the property and is caused by rain water splashing off garden furniture left by the wall.

Take away any obstacles causing rainwater to dampen the rear wall. Once the wall is dry, the inside can be treated as 1 above. Similar time to repair.

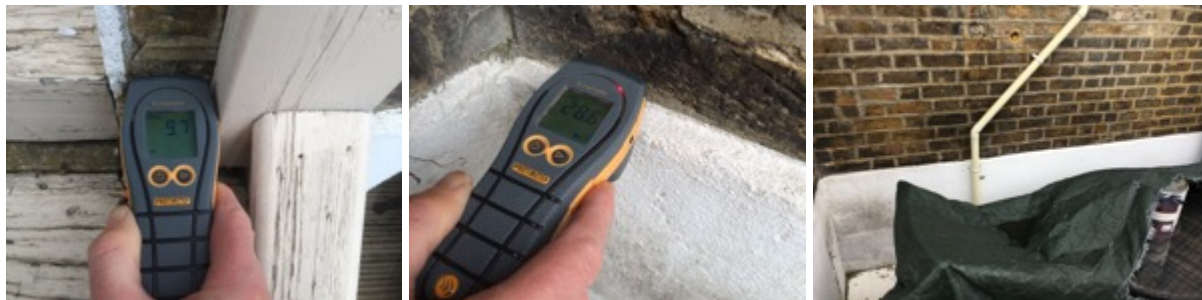
It is both visibly damp on the outside, and measured to be 28.6%WME into the corner. However, at a similar level but shielded from rain bouncing off the garden furniture, the damp meter registers on 9.7%WME. It also demonstrates that rising damp cannot be the cause. The culprit is in the right-hand photo, the green tarpaulin covering the furniture.

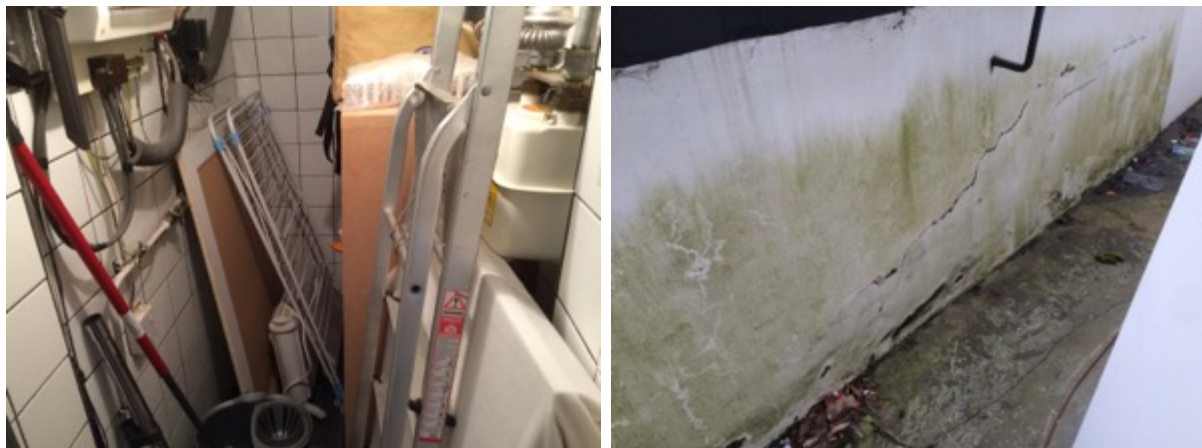
4 Other matters

The tiled area below the stairs to the front door is bound to be humid, as it was originally design for coal storage or similar. The retaining wall to the front has a plaster crack and green algae growing. Weep holes can be added. It is decorative decision to improve this wall in line with other retaining walls on the street, such as the neighbour's wall.

These areas were designed to be damp. It is our opinion that they should be kept as closely to the original design as possible. Change is the biggest driver of damp issues in a house. They could both be improved decoratively, however the damp is unlikely to be effected by decorative improvement.
