solving the source of damp

REPORT

Property surveyed XXXX

Thank you for instructing us to carry out a damp survey of XXXX. We understand that you have concerns about potential damp on the ground floor and so you wish to have an opinion from an independent expert damp surveyor. Please inform us if we have misunderstood your instructions.

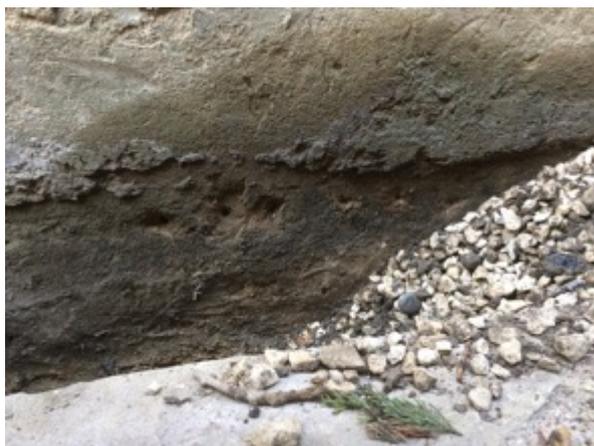
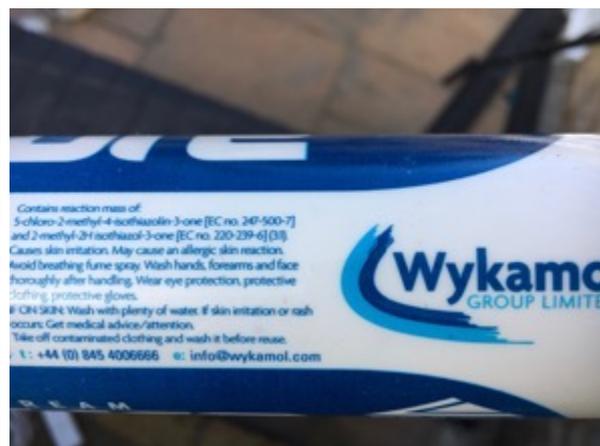
1 Left-hand flank wall

A section of the left-hand flank wall has been injected with a Thixotropic (Silane) chemical damp proofing cream. We understand the wall showed no external signs of dampness before being inject. It now appears to have a dark damp stain. The manufacturers recommend drilling the wall along the mortar bed, at the perpendiculars between bricks (“perps”) for the full length of the damp wall, with the holes sealed. However, “walls can

remain damp after a DPC installation where they are severely contaminated with hydroscopic salts”.

It may be that the chemicals will eventually dry leaving no trace of dampness. The dark colour is either caused by, chemicals blocking spread and evaporation of moisture. Or the chemicals acting in a similar way to the water, in the way light is reflect off the substrate. Giving an appearance of dampness rather than being damp.

Either way, while damp is no longer an issue, the appearance of damp is an issue, which may need to be dealt with by re-rendering the flank wall. Furthermore, the dark colour suggest that the render is not impermeable, and therefore may have been causing a bridge for water to rise over the damp proof course.

There is no evidence of rising damp, indeed the elevation, position on the hill and low flood risk suggests the property is far from a source of ground water, a necessary component of rising damp. The dark stain on the flank wall is not causing internal dampness and therefore it is only the appearance of damp that is a cause for concern.

Dampness has been caused by rainwater bouncing off garden furniture onto the un-rendered surface. Furthermore, the render to the flank wall appears to be permeable, allowing water to bridge the damp proof course.

1. Move the garden furniture at least 1.5M from the house.
2. Either wait to see if the chemicals in the Ultracure® cream dry out, or consider re-rendering the plinth, using an impermeable render.
3. To elevate condensation in the kitchen;
 - a. Consider opening up an external vent to the current kitchen extractor fan.
 - b. Consider buying an externally vented dryer (or washer dryer),
 - c. Consider installing a modern thermostat e.g. Net or Hive, that allows minimum night time temperature above 10°C.
 - d. Buy a humidity meter so as to become more humidity aware. See mouldpoint.co.uk

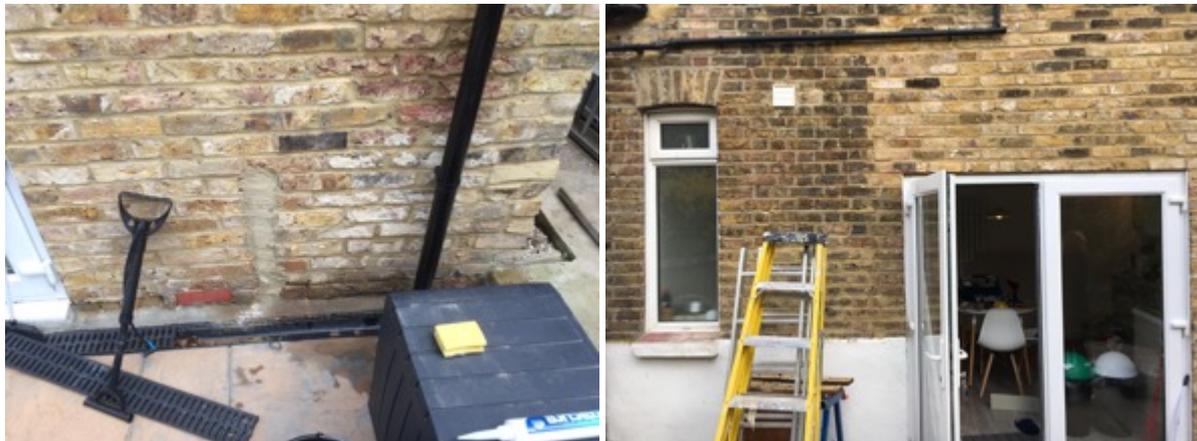
2 Rear wall

The un-render wall by the back door was damp. The profile of the damp matched the position of the garden furniture. Rainwater has been splashing onto the wall. The garden furniture was previously placed in line with the wall, creating a longer surface to splash onto the wall.
