EXPERT REPORT

Property surveyed XXXXX
London, XXXXX

This is the single joint expert report for XXXXX.

Report 14 May 2018

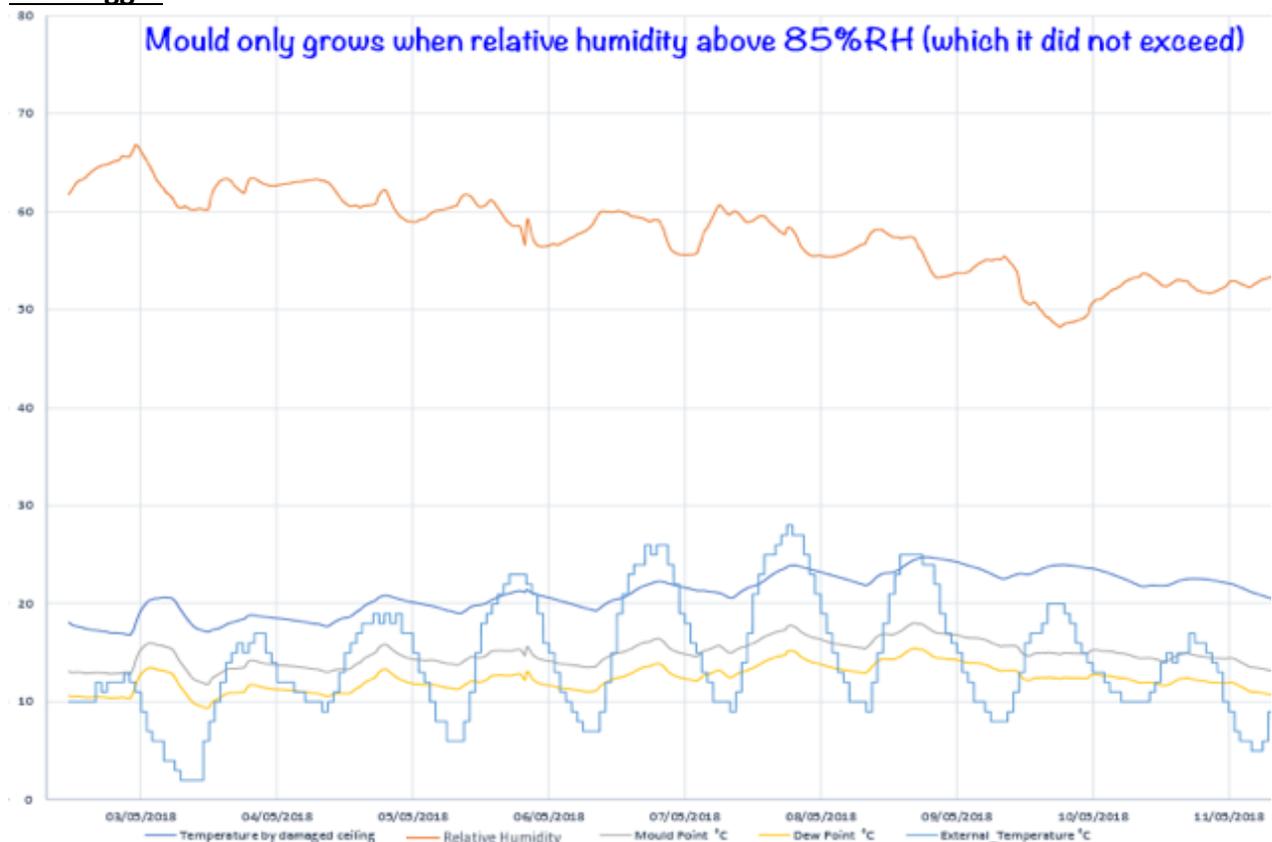
Data logger

From 2 to 11 May, SensorPush (data logger) recorded humidity and temperature changes ~5cm from the mould on the ceiling of the bedroom cupboard. Metrological data used for the external temperature was added. The red line (top) is the relative humidity measured as a percentage of air capacity. Mould only grows above 85%RH which was not exceeded.

- The humidity was too low during the period from 2 to 11 May 2018 for mould to grow.
- Likewise the humidity was too low for condensation to start.

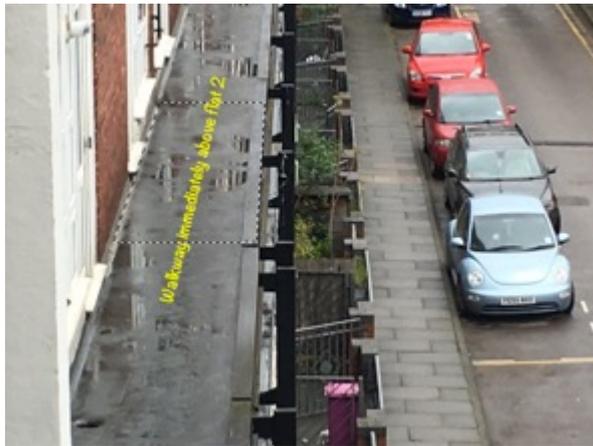
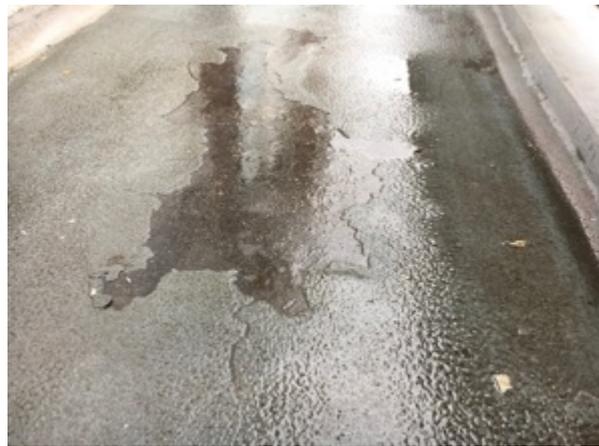
1 The walkway

The external walkway is immediately above the flat – see middle of left hand image. There was standing water on 2 May (see right-hand image). If there was ingress of water from the walkway, then the ceiling in the flat would have been moist, which it was not. And humidity would have been high, close to 100%RH. The ceiling was dry, humidity was moderate.

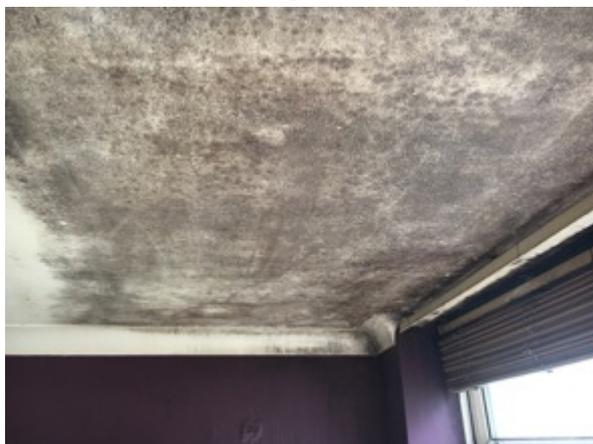
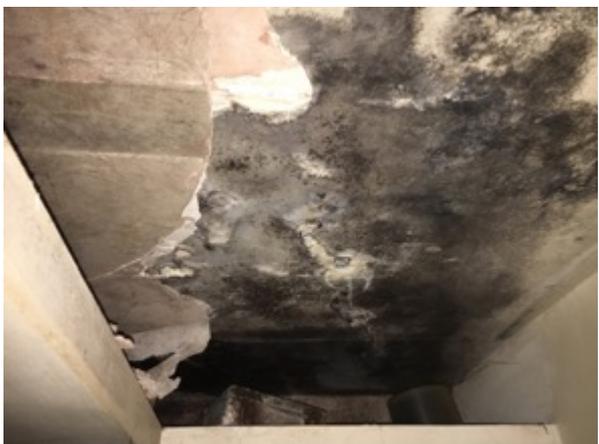
2 The bedroom ceiling immediately below the walkway

Above left, is the bedroom ceiling. Above right is of the walk-in cupboard ceiling, on 2 May.

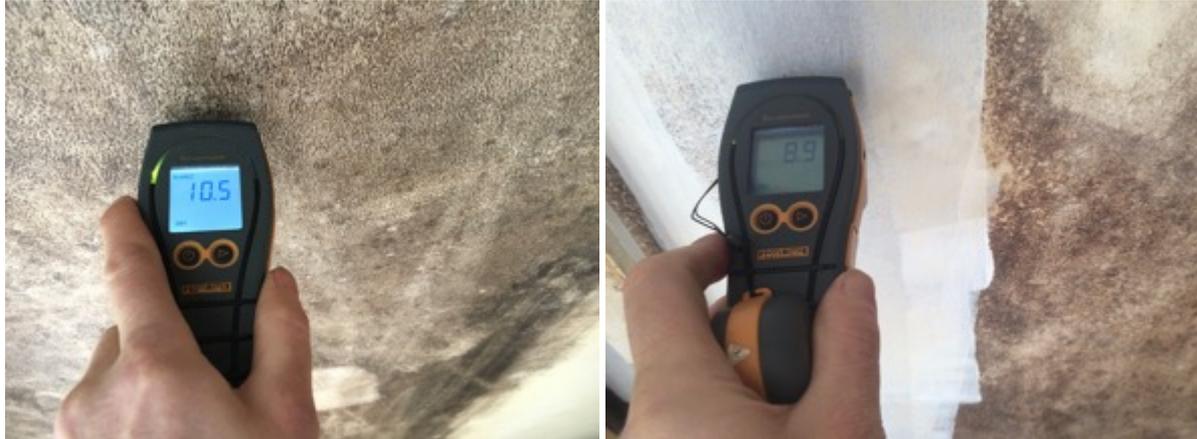
3 Damp meter measurements on 2 May and 11 May 2018

The bedroom ceiling was sample tested in 5 separate places on 2 May (example; left image measured 10.5%WME). And on 11 may (example; right image measured 8.9%WME). Both measurements are below 20%WME and therefore the ceiling was determined to be dry.

Illustration 3 - 4 demonstrates conclusively that there was no ingress during the period 2 to 11 May 2018. The Protimeter measured below 20%WME and there were no isolated brown stains, typical of water ingress, after one week despite rain and standing water.

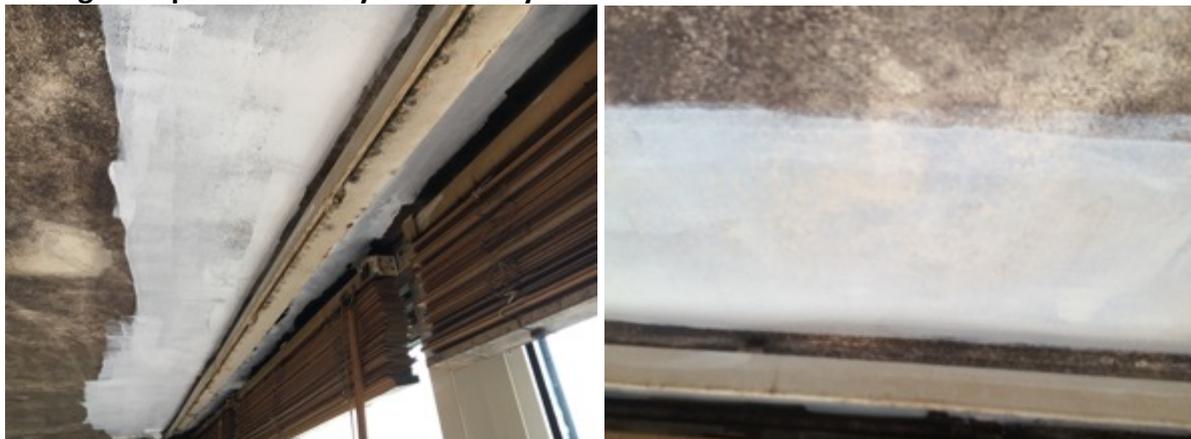
4 Fungicidal paint on 2 May and 11 May 2018

Part of the ceiling was covered with fungicidal paint. Water ingress carries dirt resulting in isolated stains below each entry point. The left image was taken on 2 May, the right on 11 May. There were no isolated stains, the we can therefore conclude there is no water ingress.

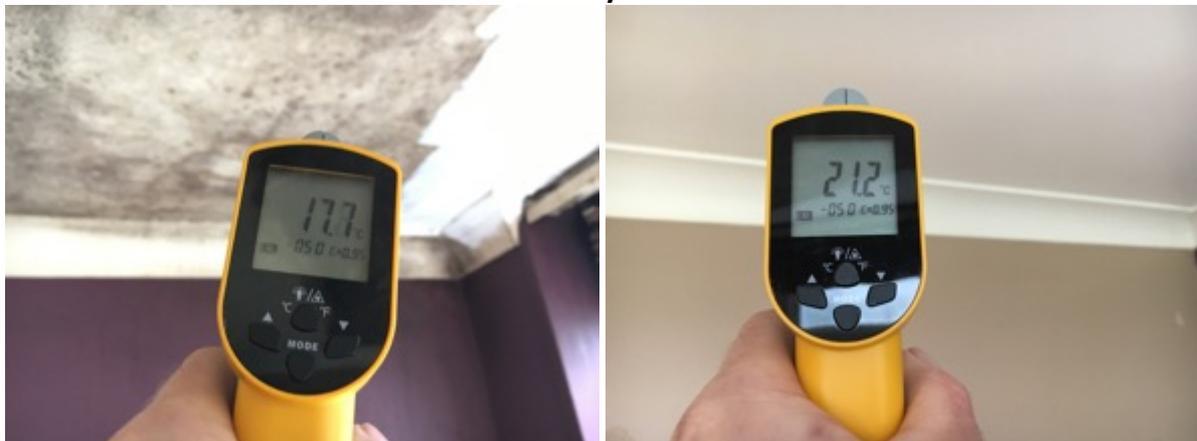
5 Thermal insulation measurements on 2 May 2018

Surface temperature readings were take of the ceiling below the walkway (left 17.7°C) and on the same bedroom ceiling away from the walkway (right 21.2°C), on 2 May.

Illustration 5 - 6 shows the reasons for the excess humidity; poor thermal insulation of the walkway and insufficient ventilation. Properties with flat roofs are often poorly insulated.

Mould grows when the relative humidity drops below 85%RH – the mould point. The colder the surface temperature, the higher the relative humidity at the surface. The poor insulation of the walkway results in mould starting under the walkway as this is colder and therefore have a higher relative humidity.

- e. Install thermal insulating plasterboard to the ceiling of the front bedroom.
- f. Become humidity aware by use of a humidity meter – we left a humidity meter on site. Use our free mould point calculator at MouldPoint.co.uk

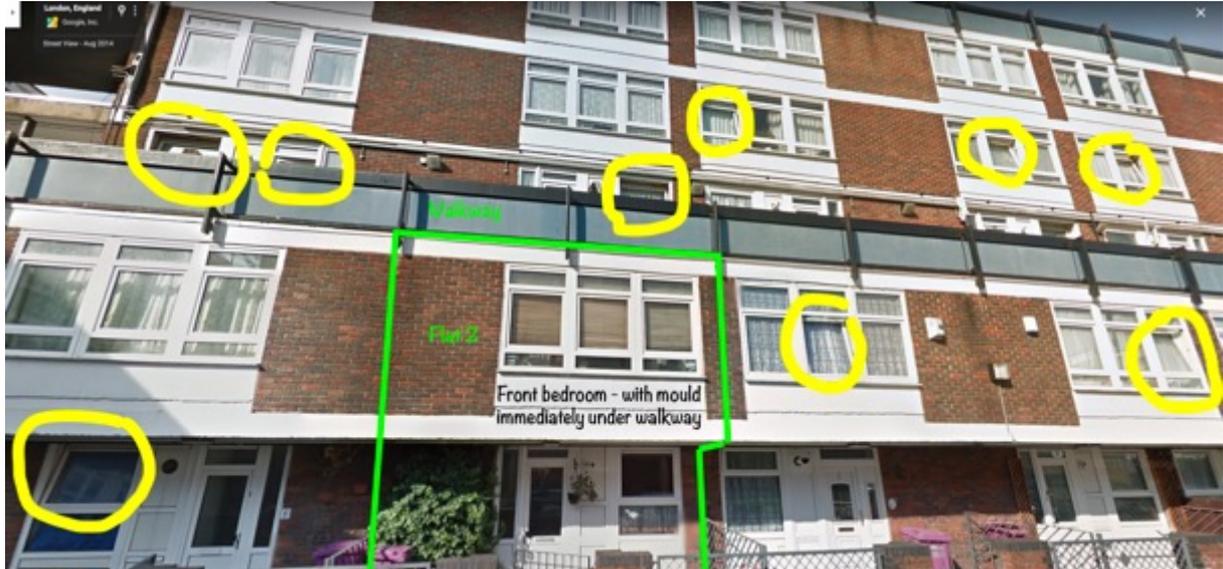
6 Ventilation

Above is a screenshot of the “street view” from Google Inc ©2014 and is dated August 2014. Flat 2 is in the centre with a green border. It is noticeable that all the surrounding flats have at least one open window (highlighted in yellow). Flat 2 has no open windows. The double-glazed windows to flat 2 have trickle vents. These are not providing sufficient ventilation.

- a. Maintain adequate ventilation, by opening the bedroom window at all times, as was the case during the survey.
- b. Fix or replace the extractor fan in the bathroom, ideally with a humidistat fan (humidity activated set at 50%RH) or light switch activated fan with a delay of at least 20 minutes.

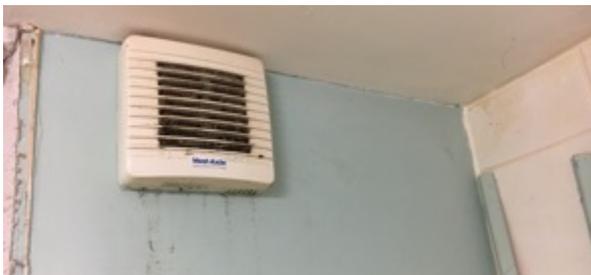
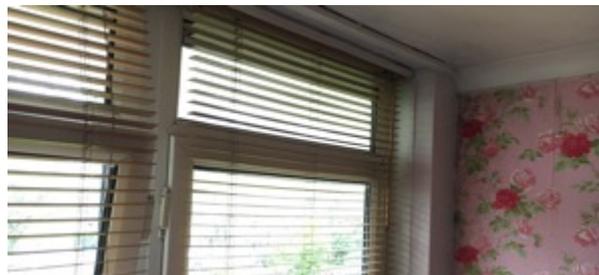
The extractor fan in the central bathroom was not working. According to Mr O’Neill this was as a result of a flood a year or so ago. It was also noted that there was mould growing on the wall on the first-floor rear bedroom, despite there being no walk way immediately above it.

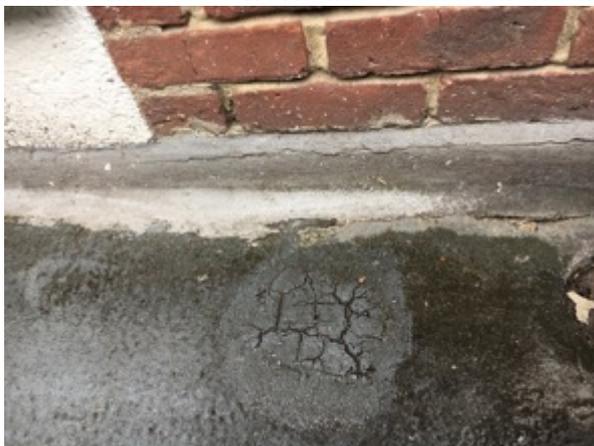
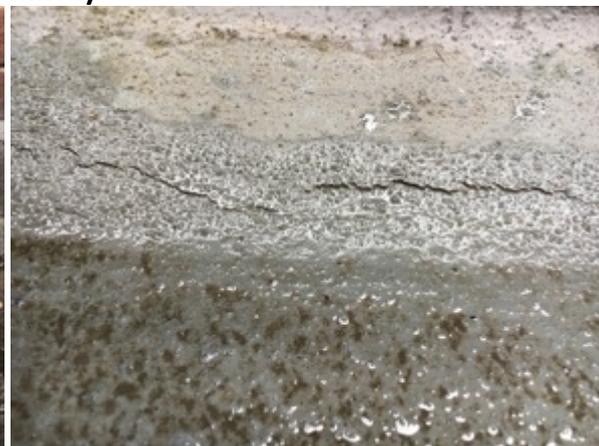
7 Other matters – work undertaken on the walkway

Material painted onto the walkway is cracking. This cracking is not causing ingress of water.

The material painted onto the walkway is cracking suggesting sub-optimal work. It is our opinion that the work was probably unnecessary since the walkway does not leak, despite the crack.
