DAMP AND TIMBER REPORT

Property surveyed XXXX

London, XXXX

I confirm that I inspected XXXX on 26 June 2018. I conclude that at the time of the survey there was no evidence of rising damp from below the original external ground level. There is some historic evidence of condensation.

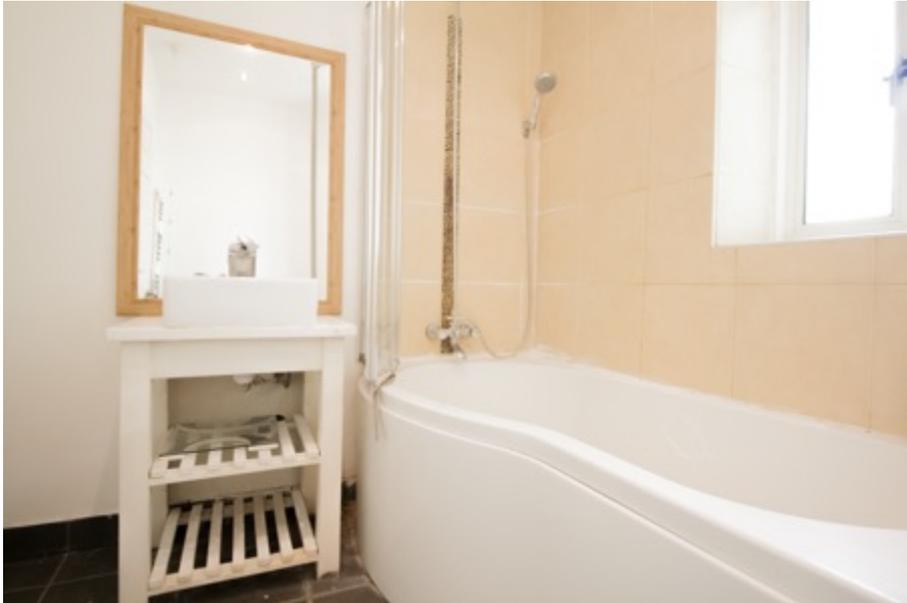
1 Flat 6 bathroom

There are high meter readings around the sink, with a line of damp rising up behind the mirror to about 1.5M.

There is no rising damp. There are two areas of damp; in the bathroom, primarily caused by water from the neighbour's shower, and in the kitchen where there has been some historic condensation and movement of salts within the plaster work. Both these areas are at risk of condensation, especially in winter.

1. Either provide an external ventilation system in the bathroom and kitchen, (light switch activated, with time delays – or humidistat although these lose sensitivity over time).
2. Or make a strict open window policy (most double-glazed windows open on a safety lock, but few occupiers are aware of this, so occupiers need to be shown).

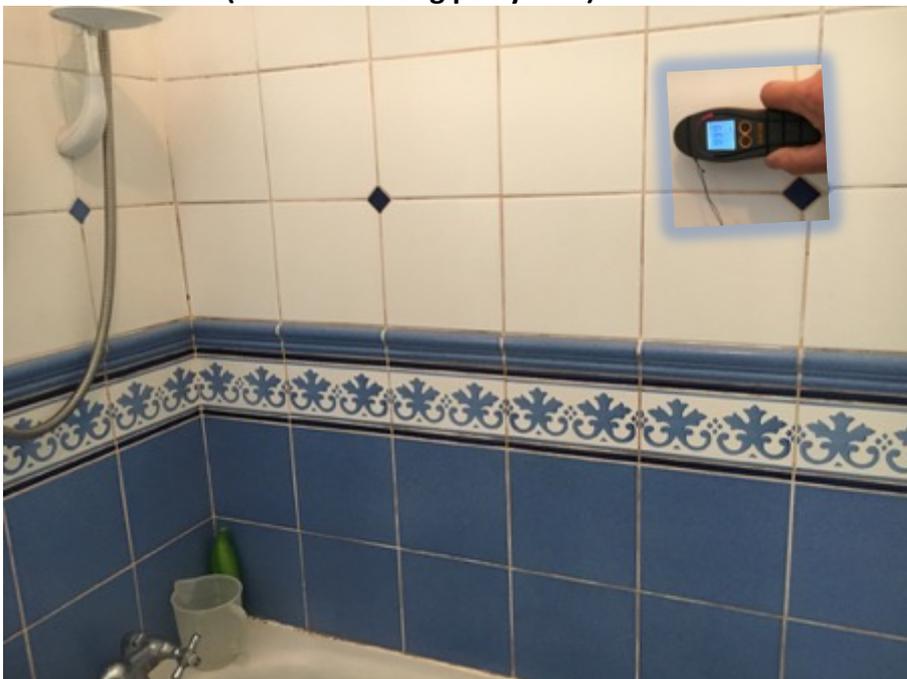
Flat 5 bathroom (with bath along party wall)

Anna, the neighbour kindly allowed me to see her flat. She has a shower over bath which runs along the party wall. The tiles were tested in search mode and found to have the highest level (see the overlaid picture above, which lines up with the back of the mirror).

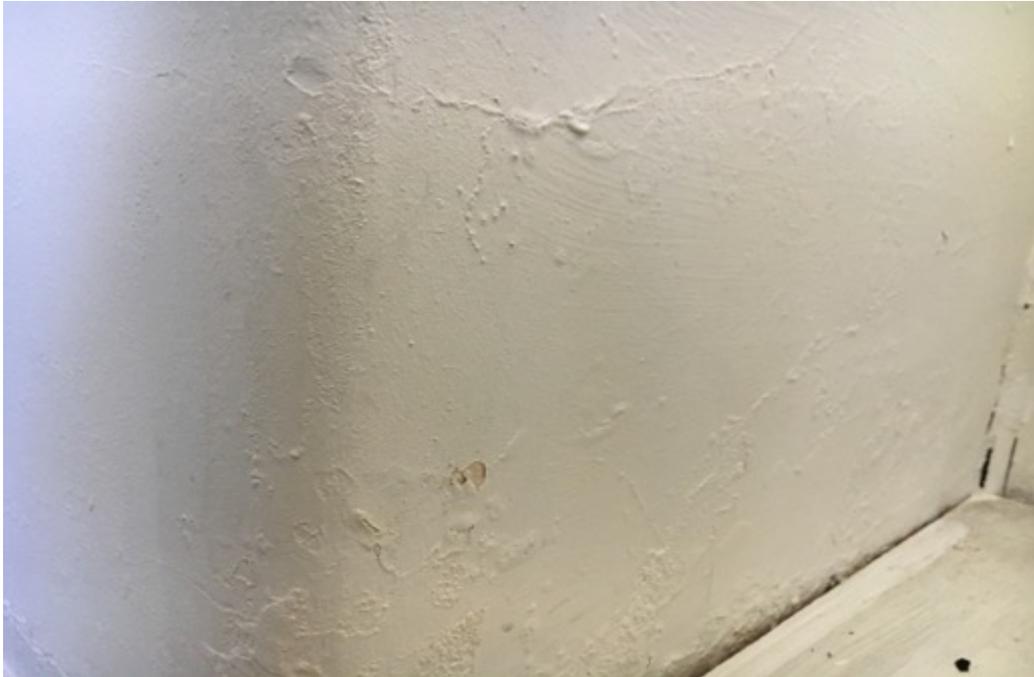
2 Kitchen

There were high damp meter readings around the kitchen back door. This is often the dampest areas in a property, as it is where warm, humid air meets cold air. Looking closely at the plasterwork there appears to be sulphate salts under the paintwork. Salts trigger high damp meter readings without damp being present. There are no visible signs of dampness.

3. Don't dry clothes on radiators. Dry clothes outdoors or use a drying machine. The bathroom with the window open and door closed, can make for an alternative.
4. The salts can be rubbed off the kitchen wall with coarse grain sandpaper.
5. Given that condensation is a risk, consider painting a fungicidal (anti-mould) paint on the final coat in areas such as bedroom external walls and the kitchen or bathroom.
6. A humidity and temperature meter is useful to encourage greater humidity awareness.

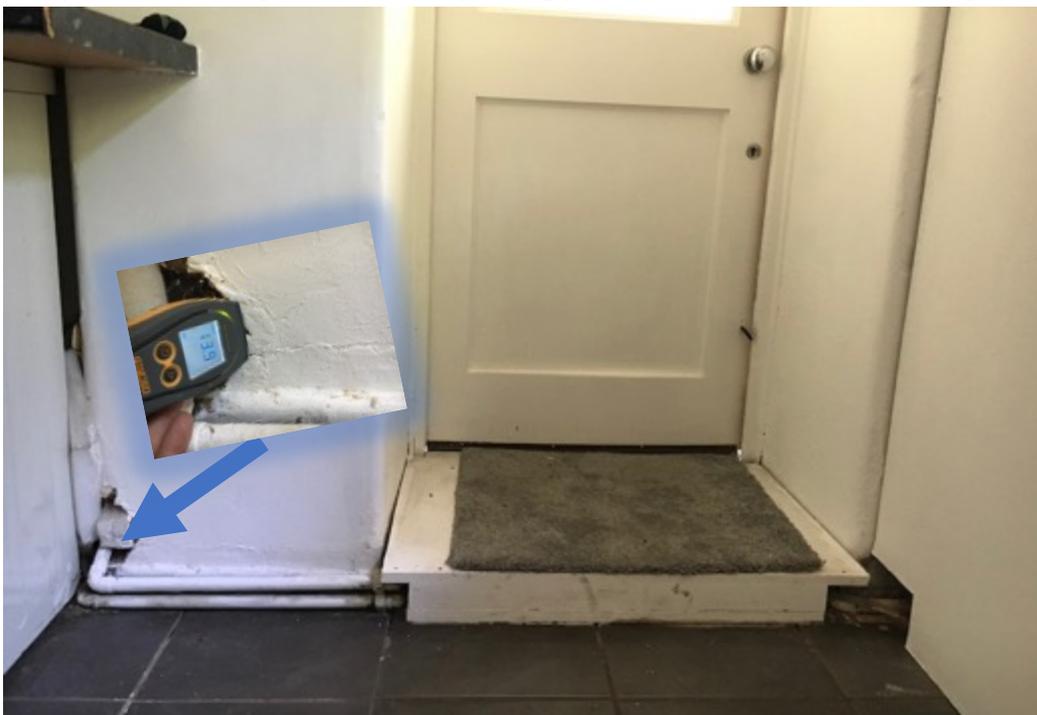
Foam was temporarily moved to expose the brickwork. The meter reading of the brickwork was only 13.9%WME, which is considered dry. We can conclude there is no rising damp.
