## REPORT

Property surveyed XXXX, London XXXX

Thank you for instructing us to carry out a damp survey of XXXX. We understand that you have concerns about damp on the ground floor and so you wish to have an opinion from an independent expert damp surveyor. Please inform us if we have misunderstanding your instructions.

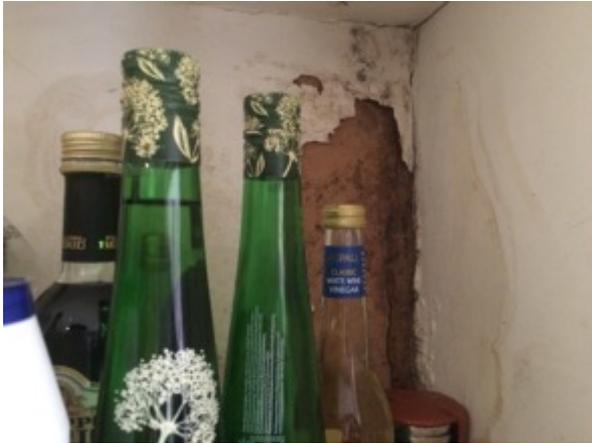
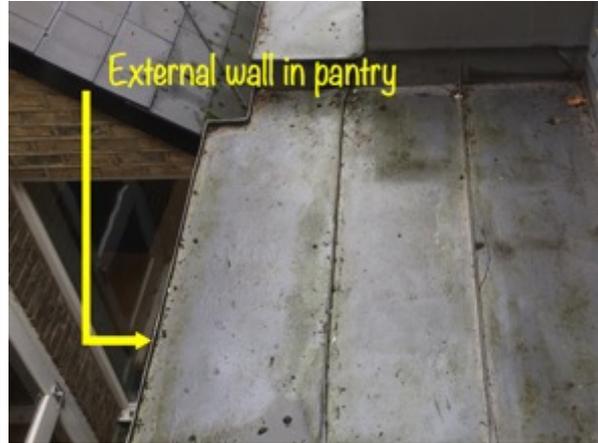
### 1c Rear extension

There were signs of mould and condensation in the pantry. The cold walls cause surface air to cool down reducing the air's capacity to hold moisture (i.e. increase in % humidity). Mould starts at 85%RH and condensation at 100%RH. The effect is exacerbated by a poor circulation of air in the cupboard and lack of extractor fan in the kitchen.

A humidity meter was left. The temperature of the wall was measured and found to be 10.4°C which is below the mould point of 11°C based on the relative humidity of 46%RH and ambient temperature of 21.4°C – use the meter in conjunction with MouldPoint.co.uk.

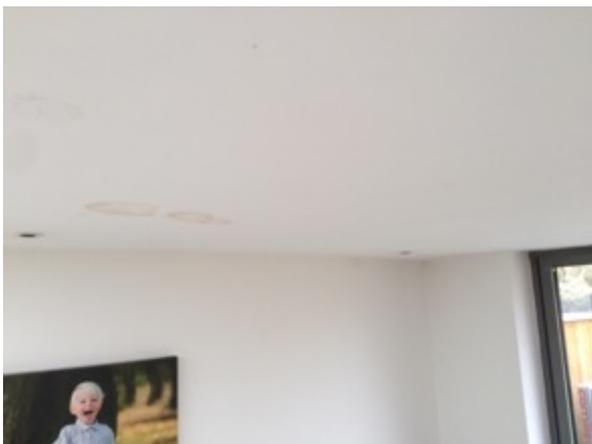
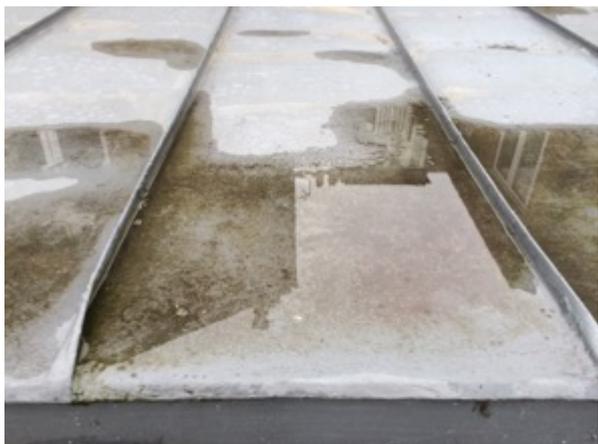
### 1b Rear extension

The rear extension ceiling was tested but not found to be damp. There were brown, tea bag like stains, which are caused by moisture from above, picking up the colour of roofing materials. While these stains are typical of penetrating damp, we doubt the roof is leaking.

The roof of the rear extension was ponding at the time of the survey. Presumably it was designed to have a continuous slope towards the rear gutter. While ponding is technically a

defect, the fact that water remains on top for a long time, suggests that the roof is not actually letting water in.

It is more likely the damp patches are as a result of interstitial condensation. Condensation forms on surfaces with a temperature below the dew point. The ceiling temperature was only around 17°C, far in excess of the dew point – and did not suggest poor thermal insulation. Within any material there exist a “dew line”. This is caused by temperature changing more rapidly than humidity from internal conditions to external conditions. In this case it is likely that the dew line is immediately underneath the roof surface. The ponding is almost certainly reducing the temperature of the roof surface by a 1°C or so, as water evaporates, enough to initiate condensation, especially on a cold winter’s night.

The cheapest and easiest way to be sure is reduce the internal humidity and monitor the resultant dampness.

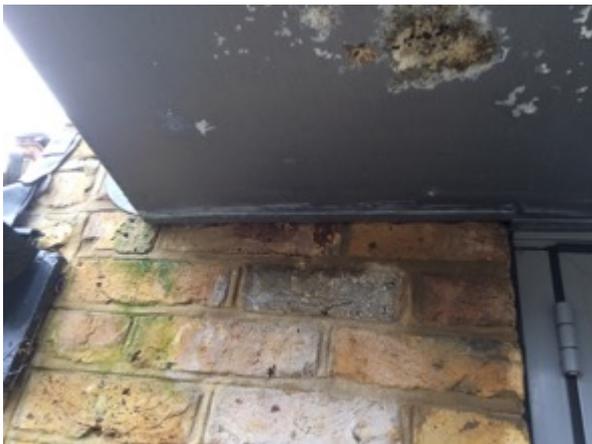
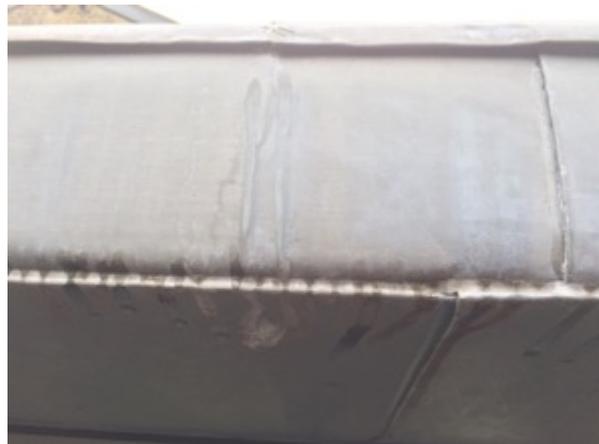
## 1c Rear extension

There are two additional issues with the rear extension. On the right-hand side (or left looking from the outside at the rear) the neighbours guttering is causing damp to bounce onto the wall, hence the green algae streak and white efflorescent salt stains. There are currently no signs of ingress, but that could change over time. Cooperation of the neighbour and lead flashing should easily and inexpensively shield the property, resolving the problem. The rear extension allows drips to roll underneath the roof onto the window and door frames causing rust and discoloration. A drip guard should be adhered to the lead to stop this.

A drip guard should be adhered to the lead to stop drips. It is better not to puncture the lead, but rather glue a strip – which could be lead – all that it required is a vertical edge to force all the rain water to drip downwards. It need not be expensive and should look reasonably elegant.

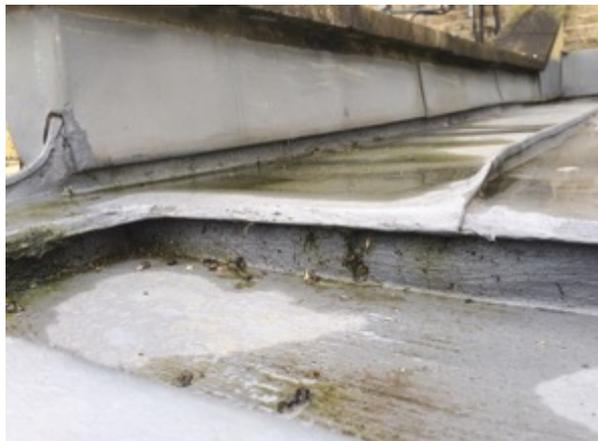
We considered the flashing to the sides of the roof. They appear to be in good order. There are no obvious signs of ingress along the flank wall.

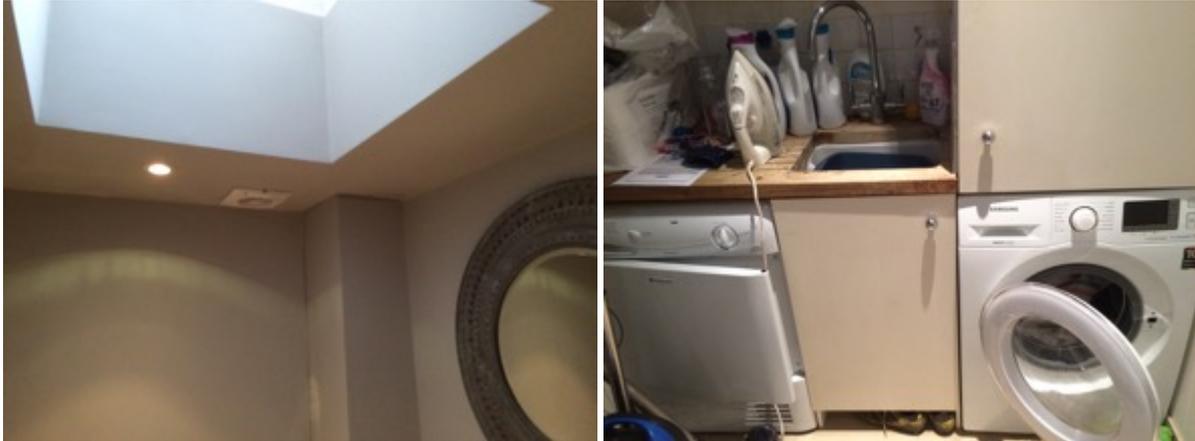
## 2 Utility room

The utility room and WC did not appear to be suffering from dampness during the survey. But they are at risk, given the humidity being created by the laundry and cold external wall in the WC. It is advisable to keep an eye on mould and dew points using the humidity meter.

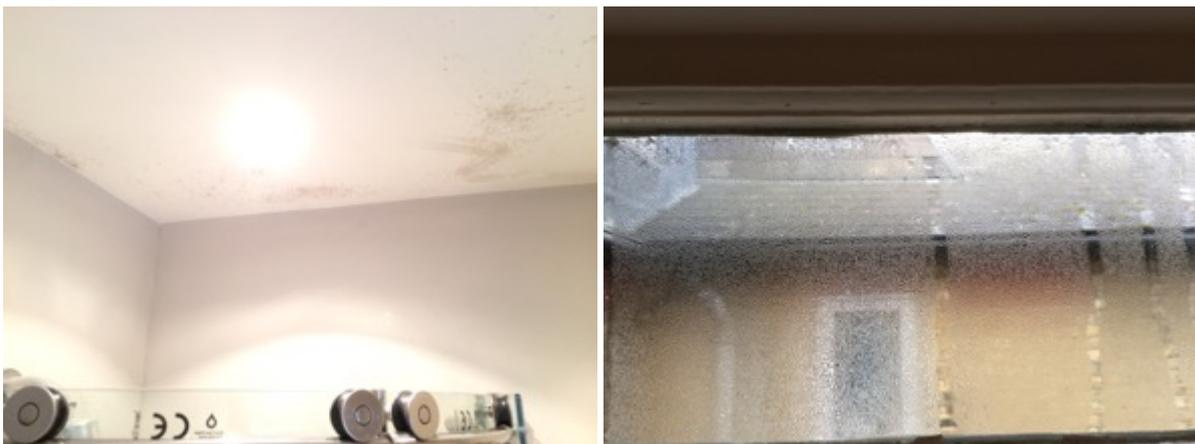
## 3 Upstairs shower room

There was mould growing above the shower and condensation on the window. The shower room has no extractor fan. The window needs to be kept open and door closed until humidity is extracted.

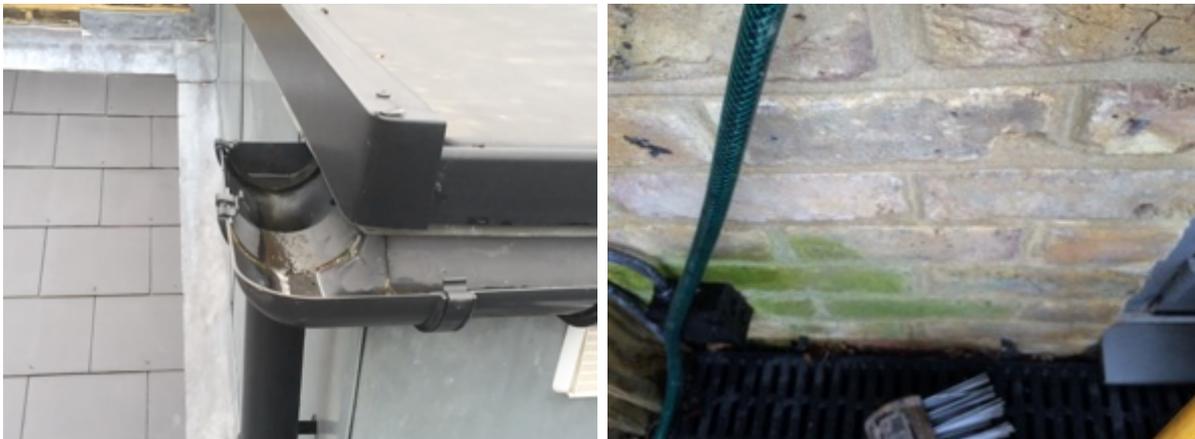
## 4 Other matters

There is green algae growing on the first floor rear roof, so we checked the roof extension, which appeared to be in good order. There was green algae growing at the base of the rear extension on the right hand side (left when looking externally). Although there are no signs of penetrating damp, it would be advisable to keep garden equipment away from the wall so that rain water does not bounce onto the brickwork.
