solving dampness

REPORT

I confirm that I inspected XXXX on 6 April 2018. I conclude that the main damp issue results from excessive humidity and condensation.

Report completed on 10 April 2018

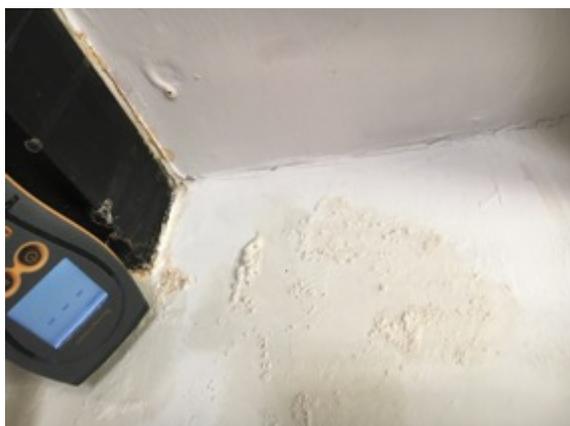
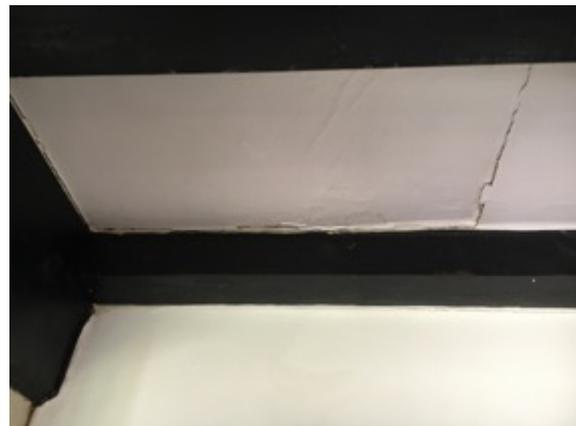
1 Damp damage in reception

The main purpose of the survey was to assure the owners that the repaired ensuite shower was no longer leaking. The damaged area was tested and found dry and ready to paint. The damp measurement was below the meters range of 7%WME (wood moisture equivalent).

- 1) The damp in the reception is ready to sand down with coarse grain sand paper, ready for painting.
- 2) Condensation;
 - a) The humidity in the ensuite shower room should be reduced either by keeping the window open during and after a shower, or by use of an extractor fan with delayed timer, or humidistat.

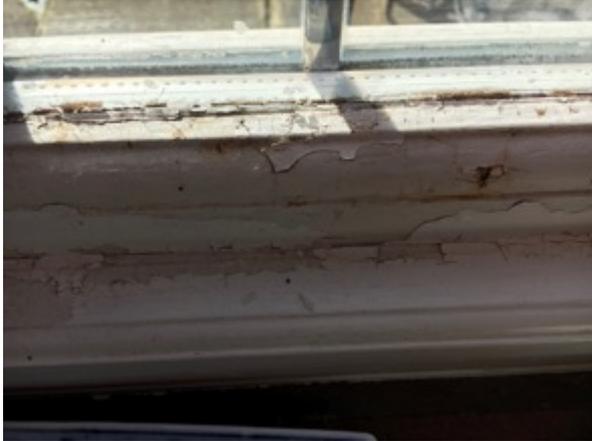
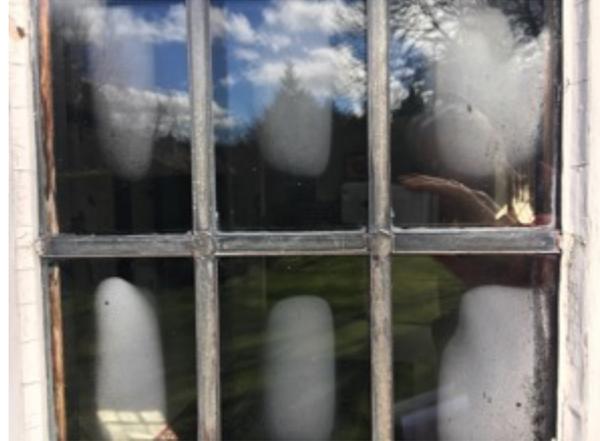
Other matters - 2 Condensation

We noted considerable condensation on the windows to the shower room, as well as other windows in the house. We left a humidity meter so that you could become more aware of humidity.

- b) The condensation to the windows with secondary glazing should either have more air movement between the two layers of glass or reduced humidity in the room affected.

- c) Where ever possibly, humidity should be extracted at source, including kitchens, bathroom and rooms occupied., such as bedroom at night by use of a window kept ajar.

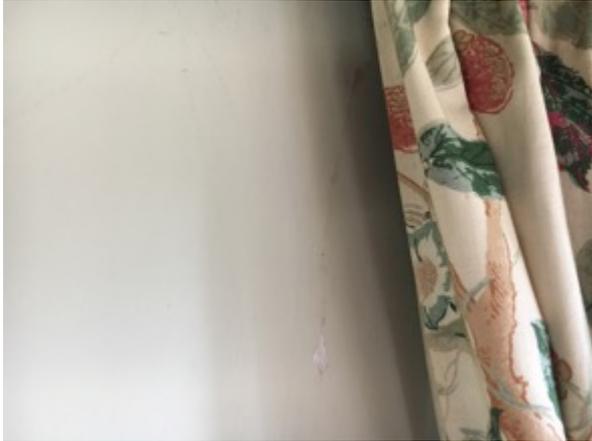
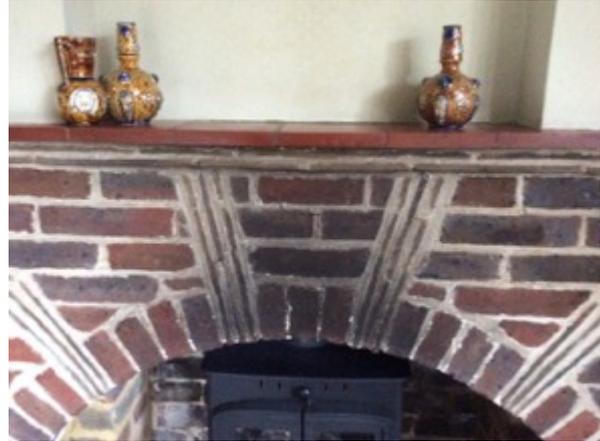
Condensation forms behind objects such as curtains and furniture as lack of ventilation reduces the movement of warm dry air. We measured damp above the fireplace. This is from hygroscopic (water attracting) salts from when wood used to be burned.

- g) If humidity persists in the reception, then the curtains should be regularly moved away from the wall to allow for air flow.
- 2b) The alcove above the fireplace. The probable cause of damp is hygroscopic salts, drawing humidity from the surroundings. The chimneys have protection from rainwater, there is no evidence of damp from above the is section, therefore it is highly unlikely that there is a source of damp other than ambient moisture.

The easiest way to deal with these hygroscopic salts before repainting with emulsion, is to sand the area thoroughly and wipe them away. Salts normally only form on the final 1 – 2mm. However, if salts persist then place a barrier in front of them.

- i. This could be section of plasterboard, cut to shape, and either finished with plaster, or paint directly onto the plaster board.
- ii. A “cheat” way of treating the salts, without losing depth, is to paint gloss onto the section of alcove, then allow the gloss to dry thoroughly (say a week depending on temperature and paint), before being sanded with coarse grain sandpaper and painted with emulsion.

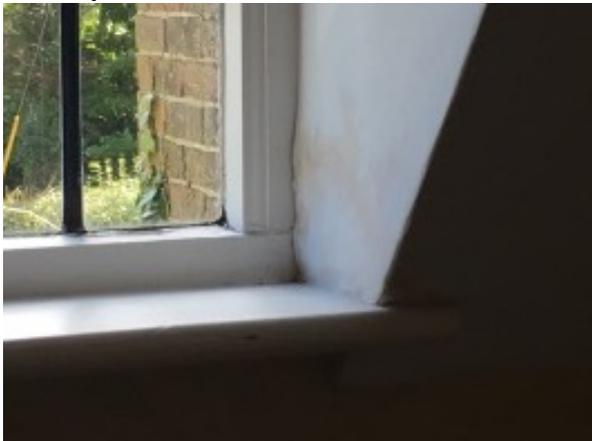
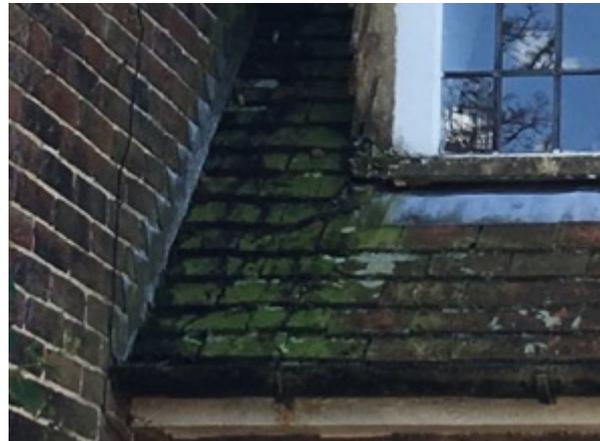
The front window was damp in the corner. On the outside we could an area of green algae rising up to the window. It is likely that the flashing has failed in this corner. The algae is not a problem but an indication that there is regular rain water unable to run off or evaporate.

3 Damp to the front window probably requires the flashing to be refixed.

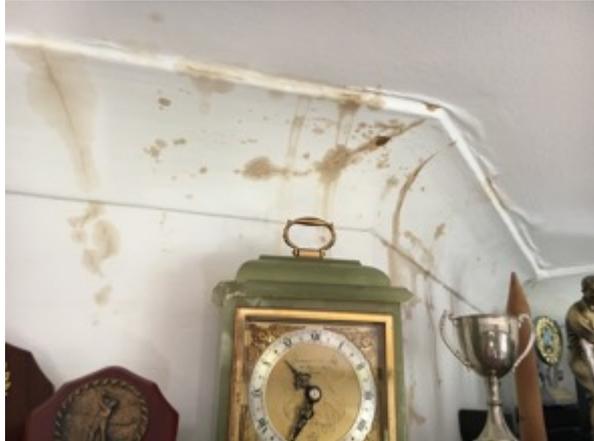
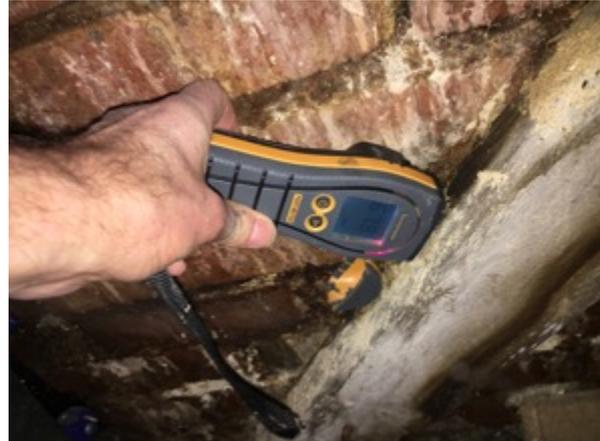
4 Bedroom fireplace

The fireplace in one of the bedroom is damp from the ceiling coving down. We investigated the roof and found the chimney above and adjoining woodwork to be damp, well above the "at risk" threshold. There were no signs of rot, probably because there is sufficient ventilation in the loft. However, rot could easily form at any time.

4 Damp to the bedroom fireplace probably needs the flashing to be refixed.

We recommend a roofing survey with cherry picker or other means to get into the hard to reach roof areas without damaging the roof in the process.

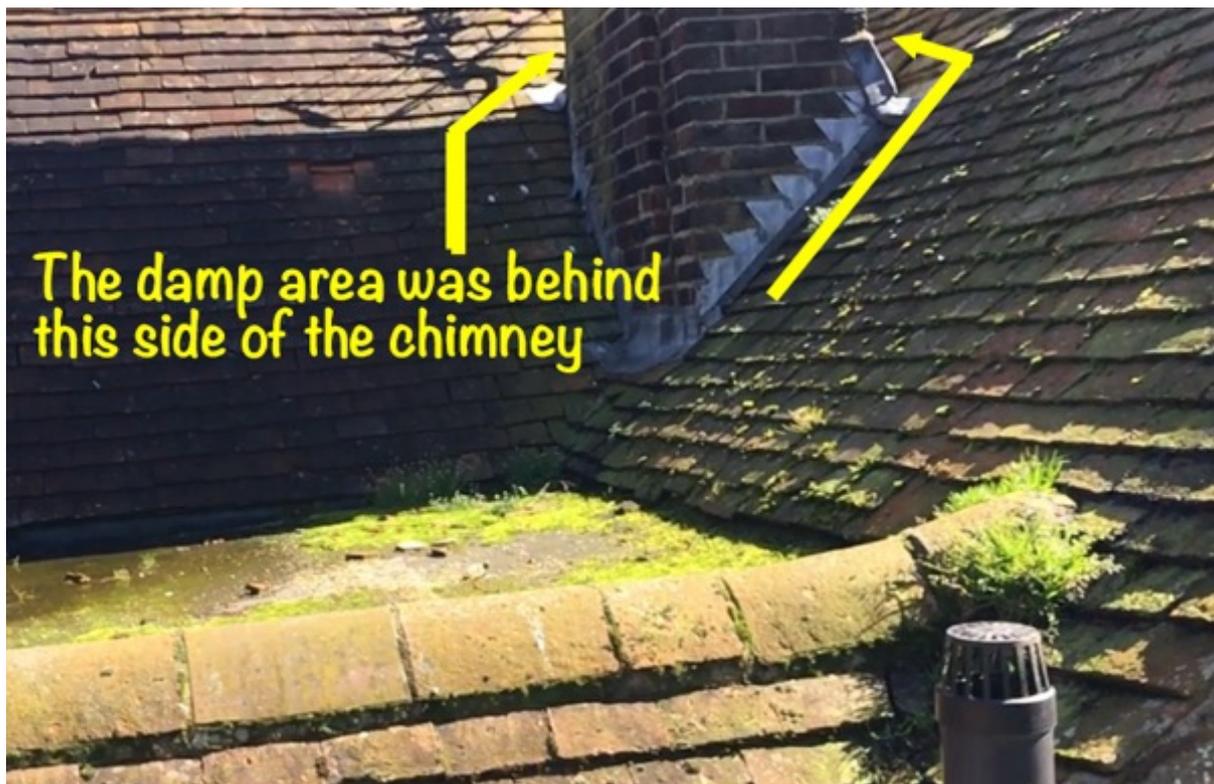
Looking at the position of the damp inside, size of chimney and the outside, we conclude that the most likely cause of the damp is damage to the valley in the corner behind the chimney (as seen from above). Without seeing it, we cannot be sure of the cause and so recommend someone view the damp side of the chimney.

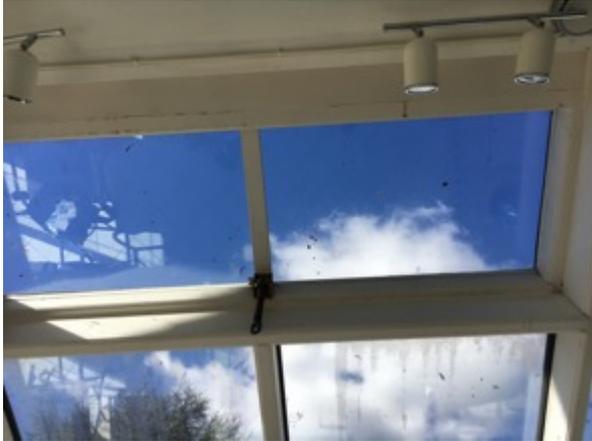
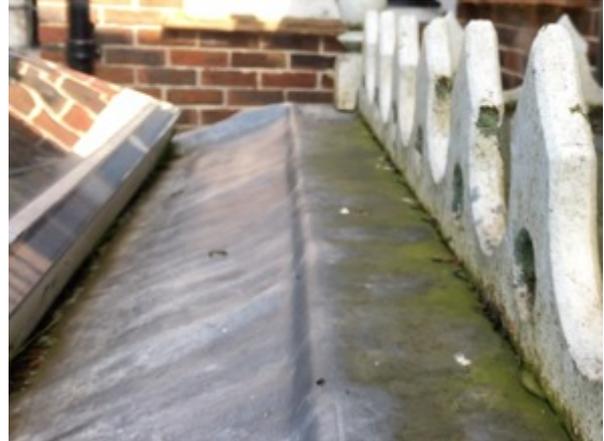
5 Conservatory

The conservatory appeared to be made to very high specifications and has lasted very well. We noted damp from above and below the roof window.

5 The company which made the conservatory is best placed to repair the leak to the roof window and rot to the wooden door sill. Experts who work or worked for the company are best placed to know what goes wrong with the conservatories and how best to fix them.

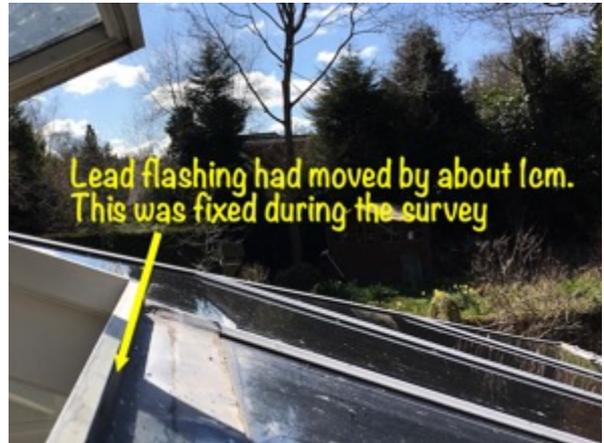
Above are photos taken from within the roof window. Algae and moss has grown up above the window, this cause be causing ingress above it. There was also a section of lead that had come away from the lower section of wood, this was fixed back and so should help keep the conservatory watertight, but won't stop water from coming from above the window.

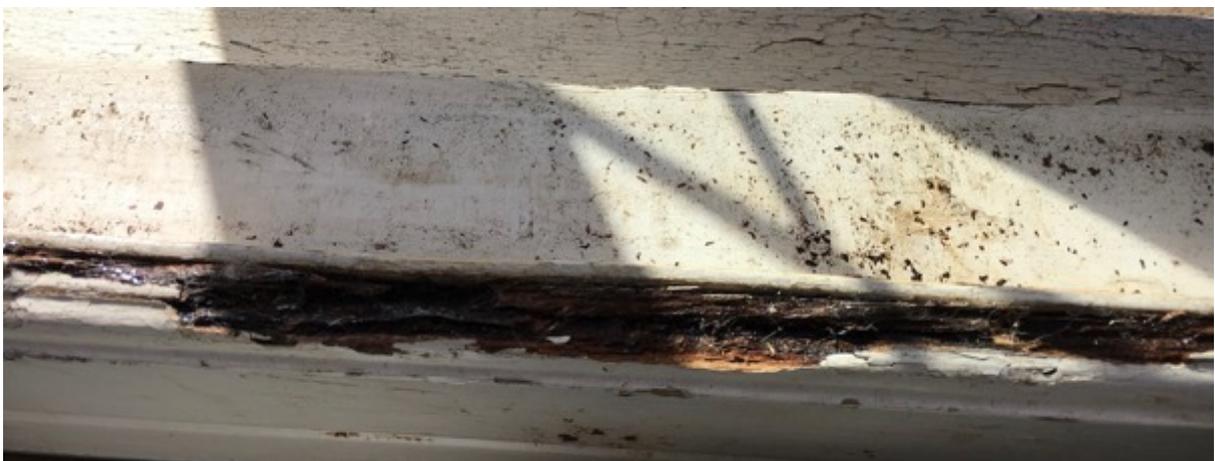
We also noted window rot on the sill to the conservatory door.
