## REPORT

Thank you for instructing us to carry out a damp and timber survey of your second floor flat. We understand that you own the lease to flat and that you have a record of damp penetrating from the top floor roof terrace since you moved in April 2010 and the freeholder has failed to rectify the underlying fault. Please inform us if we have misunderstanding your instructions.

I confirm that I inspected Flat 6, 56 Westbourne Drive on 6 March 2018.

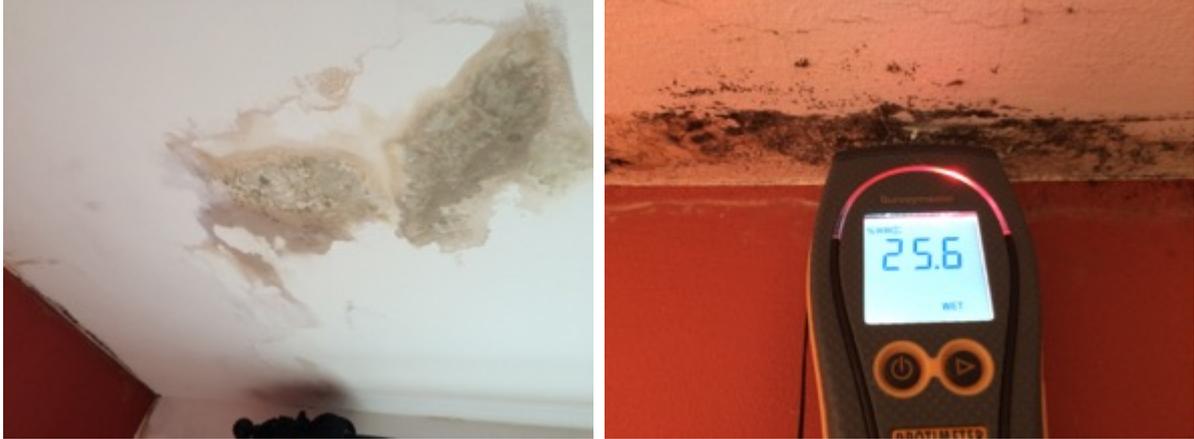
### 1 Damp on bedroom ceiling investigated

The mouldy patch on the bedroom ceiling was tested with the damp meter, and found to have only about 10% WME, which is considered dry. One area showed an elevated meter reading. This was along the left-hand wall stretching about half a metre from the corner, coinciding with the roof terrace hopper. We investigated the damp area by cutting out a section of plaster board. A second area was investigated, where mould was growing

Damp staining stretches across the bedroom from left to right. There is a large patch of mould in the middle. Some areas have been painted with an antifungal paint. To the left, there was damp patch, also with black mould, which could be toxic and could cause serious health issues. We cut open a 50 x 100mm rectangle, inspection hole to the ceiling, where the elevated damp meter reading was located.

1. If any of the rotten wood is structural (see architect's drawings), then this wood must be removed and replaced with treated wood.
2. The roof void must be dried out. The carpet should be protected from water.
3. The bedroom ceiling needs replacing.

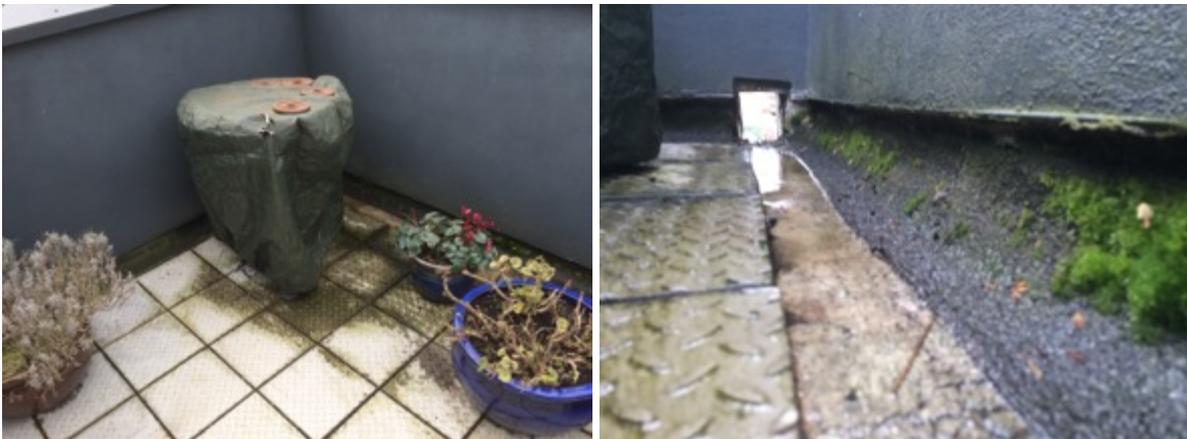
### 2 The roof terrace above

Directly above the elevated meter reading is a roof terrace made from layers of bitumen felt. We tested the hopper (right hand photo, that sits above the left hand corner of the bedroom) by pouring water onto the roof terrace towards the hopper. The hopper and down pipe did not leak. A surprisingly large amount of the water remained on the roof. Bitumen felt is designed to be used on roofs with a fall of greater than 4°, currently there is no slope. This is evidenced by the green algae to the right. Water is finding ways to penetrate the joints in the roofing material through minor defects or joints. The entire roof terrace was holding water. Water was splashing up between the paving stones as they were trodden on, even though it wasn't raining at the time.

The bitumen felt (or Reinforced Bitumen Membrane) used to weatherproof the roof terrace above Flat 6, has failed to stop the ingress of water. Bitumen felt was the wrong choice as;

1. The roof does not have adequate rainwater disposal. The slope is insufficient to direct water away from the roof. When rainwater is in constant contact with seals, moisture inevitably finds its way past the seals within and between bitumen felt sections.
2. Paving stones are laid on the bitumen felt and walked on. The movements of paving stones on the weatherproofing felt, risks puncturing the felt and aggravating joints.

1. Weatherproofing of the whole roof terrace does not meet NHBC and Building Regulation requirements and needs replacing, not just the area above the bedroom.
2. Alternatives to bitumen felt, including fibreglass and EPDM rubber roofs need to be assessed for water resistance and durability of the roof terrace in its current form.
3. Unless a solid concrete roof is used (which is unlikely to be economic), water will need to be managed with whichever roofing material is chosen. Water must be managed by;
  - a. an incline to stop water ponding "direct precipitation which enters the roof towards the outer face,
  - b. strengthening of the roofing material to ensure it is not punctured by paving stones being walked on,
  - c. Ideally, ventilation of the roof void to allow water that gets through, to evaporate.

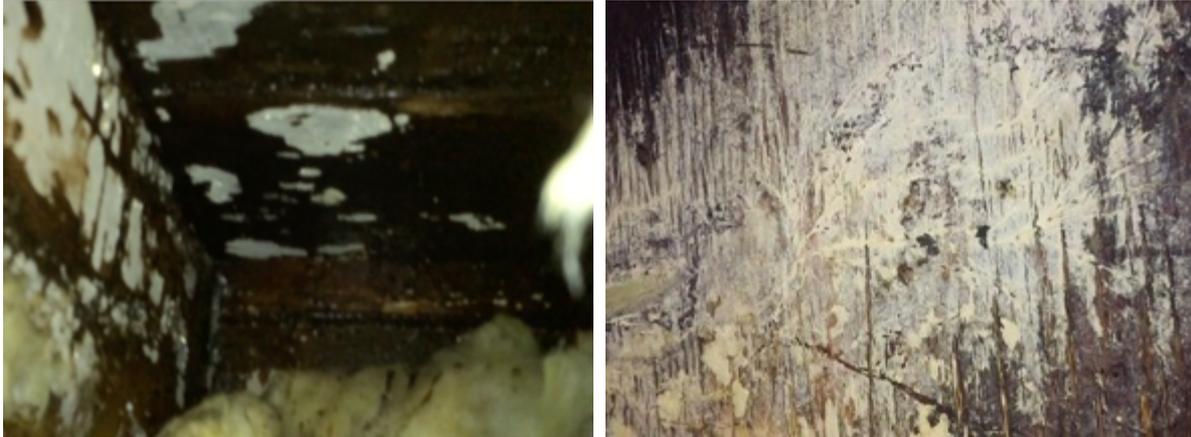
### 3 Looking inside the inspection hole

The above left-hand photo is looking slightly upwards at the left-hand corner. The insulation was sopping wet within the inspection cavity. Water can be seen dripping down the wood on the left-hand, by the wall. White rot was abundant. The wood was spongy and had lost considerable strength. The white rot was *Asterostroma*, a family of wet rot. There was no ventilation to the roof, or at least no adequate ventilation.

1. Although not a building regulations requirement, the roof void would not have been as wet had there been ventilation.
2. New timber should not rot as modern timber should be pre-treated with a fungicide.

1. The roof void should have vents fitted to allow a through-flow of air.

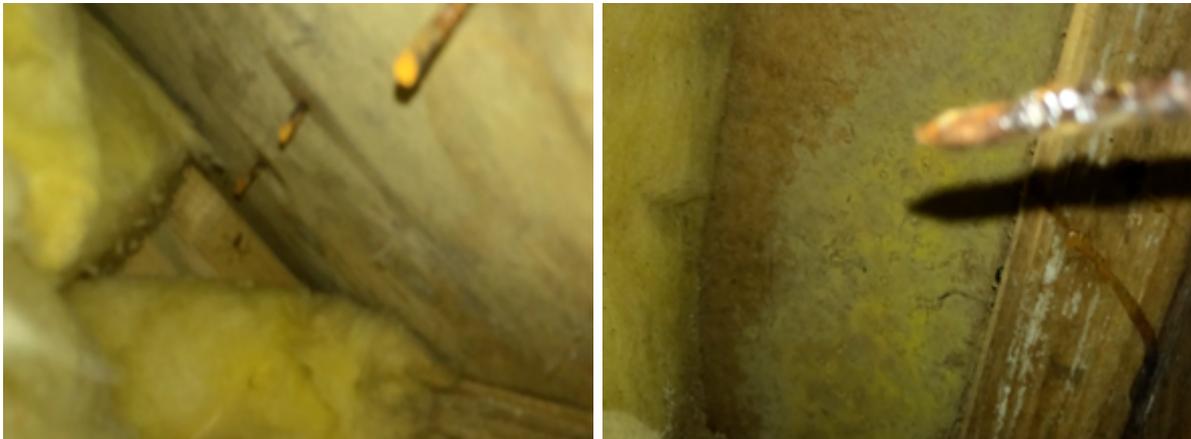
### 4 A second inspection hole was cut into the mould in the centre of the bedroom ceiling

The area above the mould was damp. Water was glistening off a series of rusty nails. Water was also running along a metal channel created by the metal ceiling frame. There were damp stains along the plasterboard edges all over the bedroom ceiling. The wood was found to have bowed, which would contribute to the ponding. The plasterboard has also bowed due to the extensive water damage.
