REPORT

For and on behalf of XXXX,
Property surveyed

XXXX,
London, XXXX

Thank you for instructing us to carry out a damp and timber survey of the ground floor of XXXX. We understand that you own the flat. That your buyer's Homebuyers Report highlighted potential areas of damp. Please inform us if we have misunderstanding your instructions.

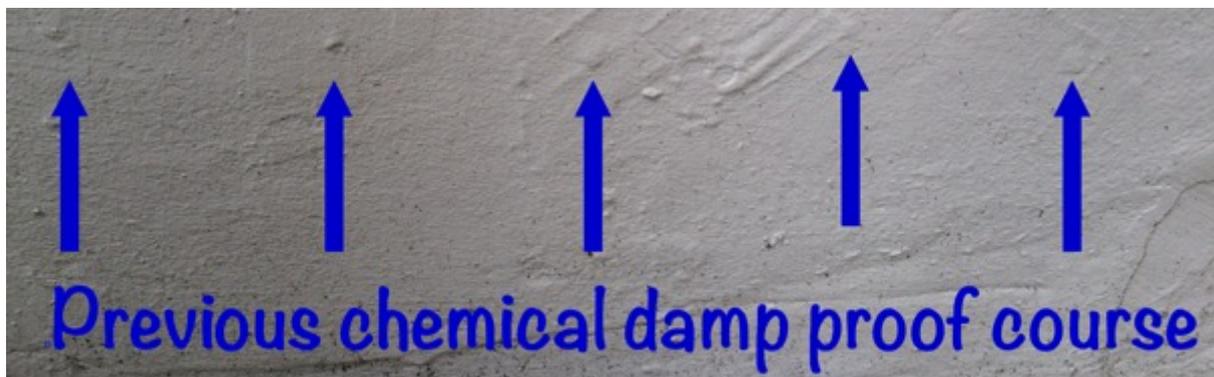
There tell-tale signs that a chemical damp proof course is already in place. The round ridges highlighted in the photo above, cover drill holes used to inject chemicals.

Chemical damp proof courses rarely address the cause of damp. In this case the cause of marginal dampness deep within the wall, is a blocked gully, which is inexpensive to fix.

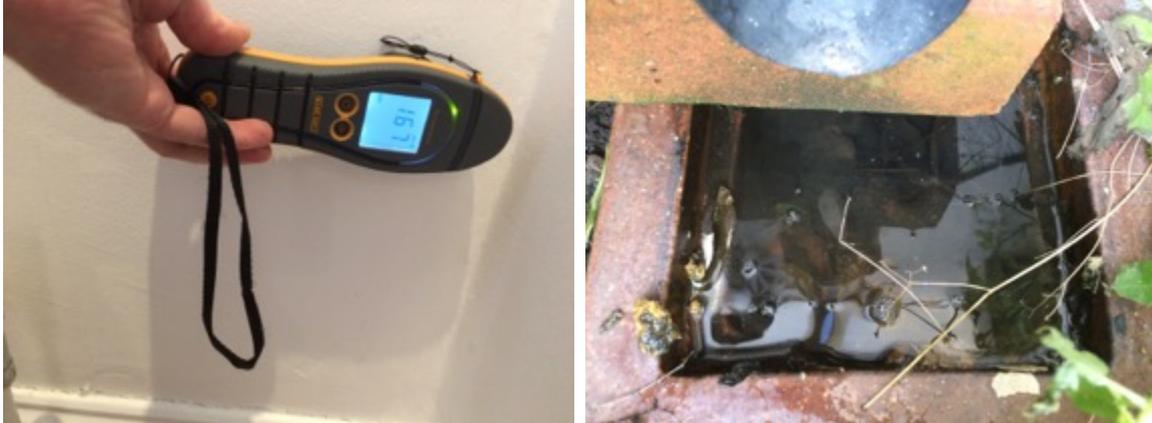
1 Cause of marginally elevated meter readings in front bedroom

The extra-sensitive search mode (left photo) identified a marginally higher meter reading in line with the blocked drain outside. The reading of 167 is “dry” and there was no spoiling to the paintwork. However, for the cost of a pair of “Marigold” gloves and a few minutes work, it would be worth clearing the drain (right-hand photo).

We recommend you clear the blocked gully to the front and unblock the paint from sub-floor ventilation, also to the front.

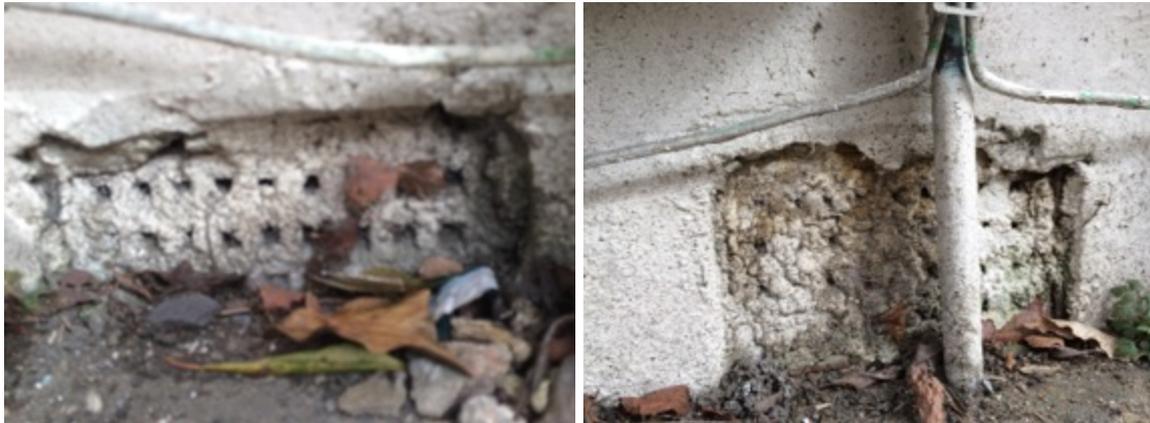
2 Sub-floor ventilation to front bedroom

Both vents to the left-hand bay, under the front bedroom have been blocked by paint. It would be better to unblock them by carefully drilling out the paint from the blocked holes. Ideally there should be a gap between the vent and the earth to stop rain bouncing or running in. This is less of an issue as there is protection from rain, by overhangs.

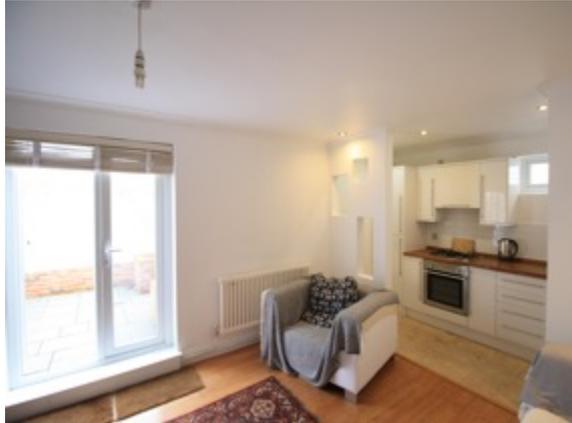
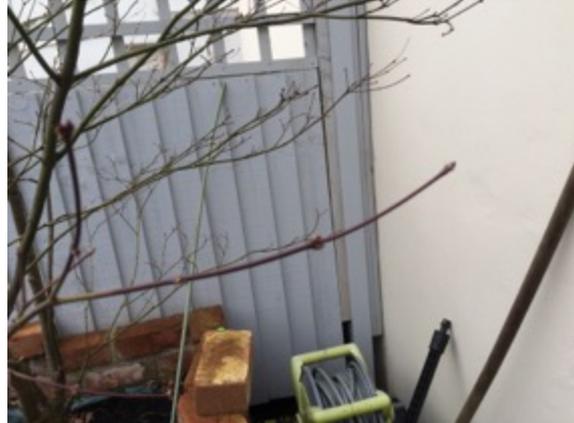
3 Kitchen

Similar to the front bedroom, there was a marginally higher damp meter reading in the kitchen which lined up with the fence. It is likely to be caused by a screw securing the fence to the wall. There was no spoiling of paintwork, so nothing to be concerned about.
