REPORT

Property surveyed XXXX,
London XXXX

Thank you for instructing us to carry out a damp survey of XXXX. We understand that you have concerns about damp on the exterior walls and steel beam and so you wish to have an opinion from an independent expert damp surveyor. Please inform us if we have misunderstanding your instructions.

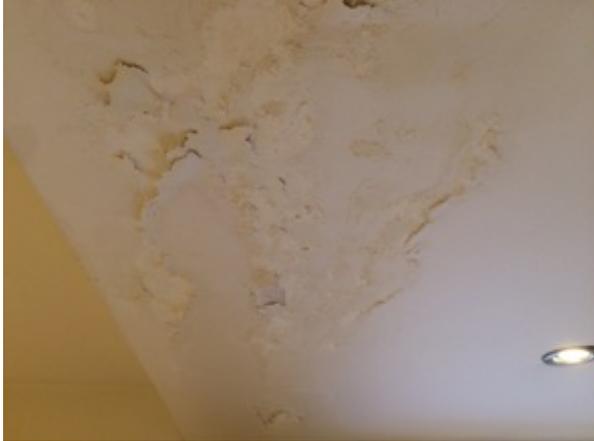
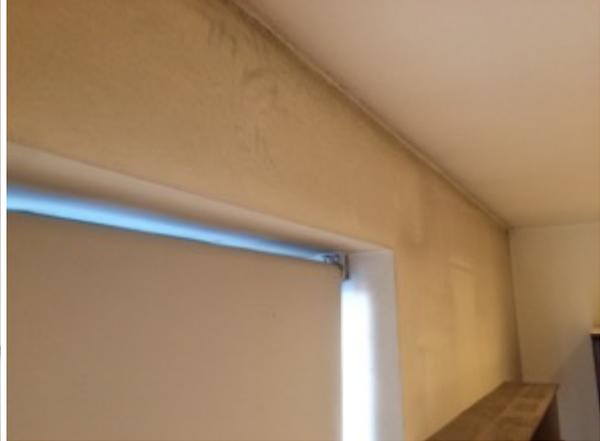
1 Condensation

The primary cause of dampness in flats 12 & 13 is high humidity resulting from insufficient air flow into the properties.

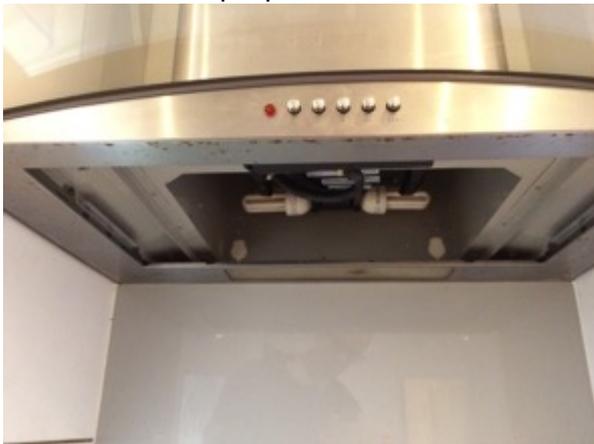
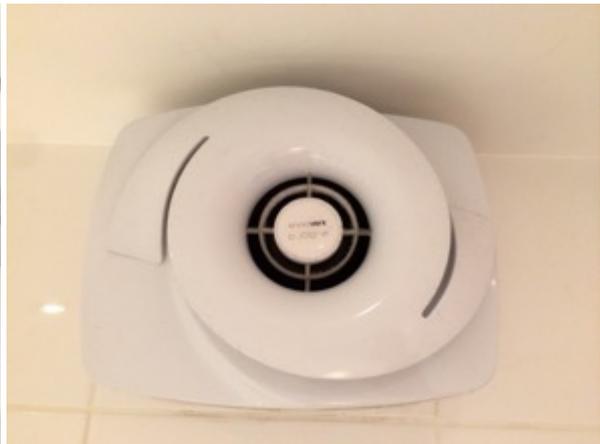
Both flats had sufficient ventilation out of the property, but unless the window is opened, the extracted air will not be replaced, causing a negative pressure difference, rendering extractor fans inefficient at extracting humid air.

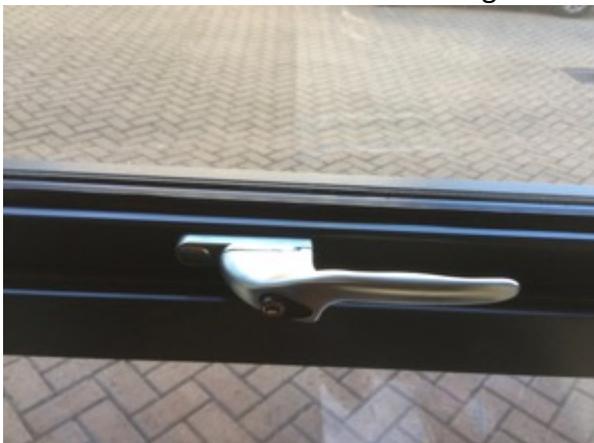
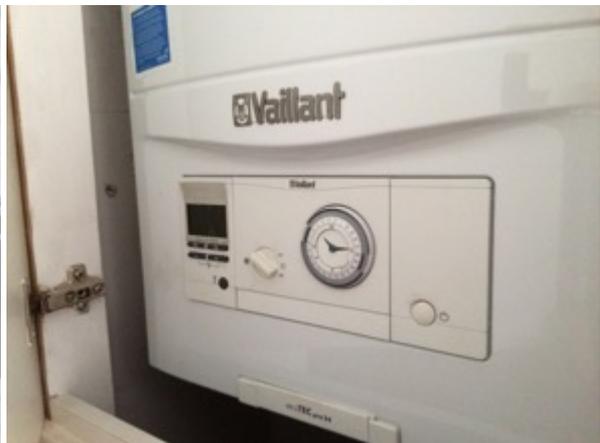
Both flats have windows that can be locked open, kept ajar, by about 1cm safely at night. Both flats had heating systems with no thermostat – the boiler uses the temperature of water from the return pipe to self-regulate heating.

- 6) The windows can be kept open safely at night, locked on the safety latch (kept ajar safely by about 1cm).
- 7) There is no thermostat. It has become a building regulations requirement to have a thermostat. One of the key issues is keeping the temperature above the mould point typically about 12°C mouldpoint.co.uk at all times of day and night. This is best achieved with a modern thermostat, such as a Hive, Nest, Tado etc. as they allow for multiple time and temperature settings. For instance at night you may want a minimum temperature of 12°C, but 20°C during the day when occupants are up and about. Currently the heating is either on for many hours, or off. It's off for most of the night when the external wall is at its coolest.
Ideally the thermostat should be placed somewhere with a similar heat to the inside of the external walls - probably in the corridor by the front door.

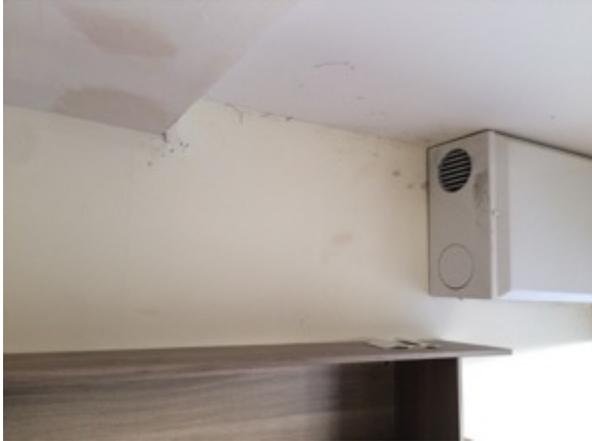
Flat 12 had a humidistat by the front door. This appeared to make very little difference to extracting the moisture at source, bathroom, kitchen and bedrooms.

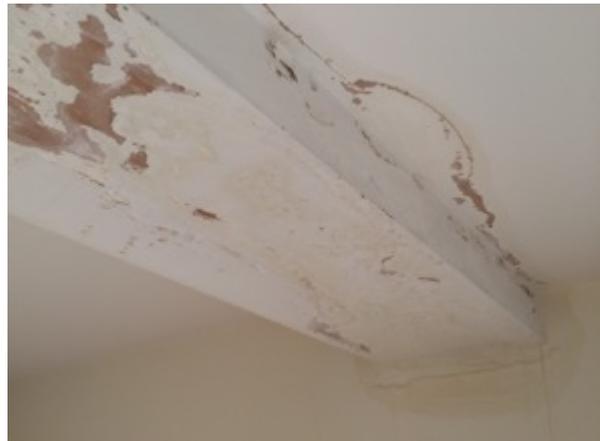
2 Interstitial condensation

Condensation that forms within building material, is known as interstitial condensation. In this case condensation from humidity generated within the flat forms around the cold metal joists holding up the external wall of the first-floor flats.

We cannot be 100% sure there is no leak without using a dye. But it is high likely that condensation is cause, given that it only occurred along the beam when there was snow outside and very cold. Furthermore it occurred in both properties at the same time and there was extensive mould, which is evidence of high humidity.

In a sense it is irrelevant whether it is interstitial or surface condensation, as the method of treating it is the same - reduce humidity, by keeping windows ajar, even when it is cold outside.

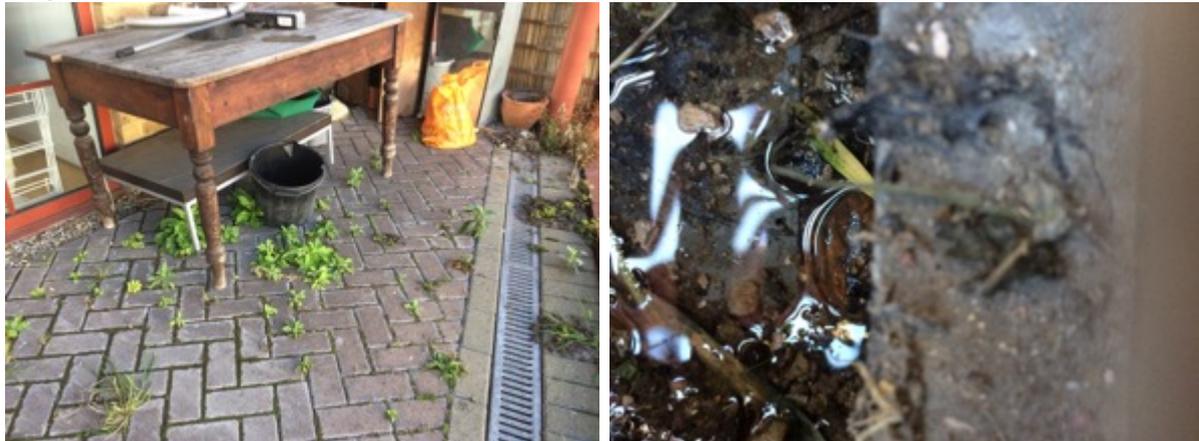
3 upstairs balconies

There are signs of water being in continual contact with the balconies upstairs, such as the greenery on the patio area, and water in the drain. Given the water to the joist only occurred to flat 12 during the snow, it seems unlikely that there is a leak from upstairs – otherwise it would have happened during rainstorms at other times of the year.
