*Ground floor apartment with a manual bathroom extractor fan and open plan kitchen with no obvious extractor switch. There is mould around the bathroom and bedroom and signs of condensation. The simple solution is to improve ventilation and heating balance.*

**HOMEBUYERS DAMP & TIMBER REPORT**  
for XXXX  
4 November 2019

*The property is a ground floor flat. The front door faces west.*

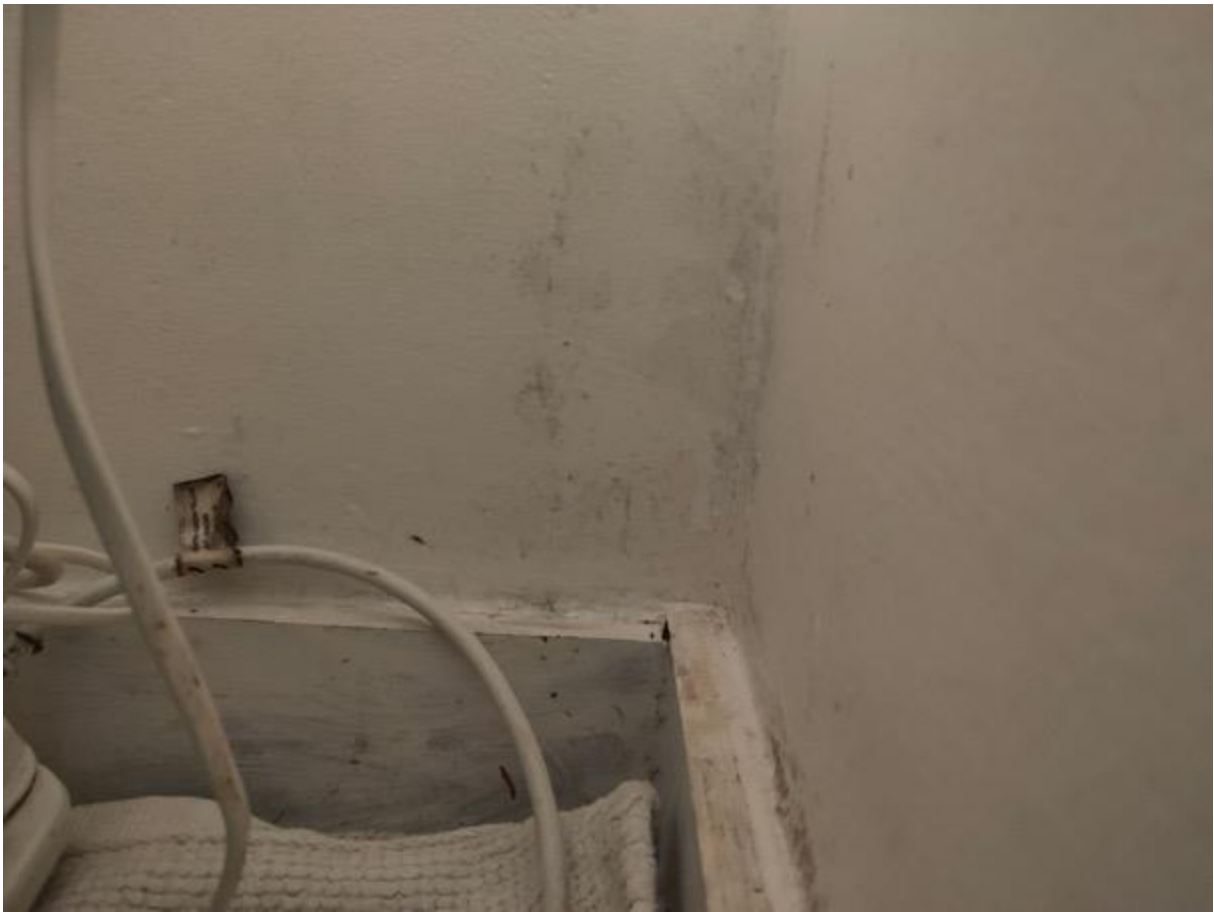
*Findings: there were signs of condensation and mould. I tested the inside of all external walls every 1M, the base of the walls by external entrances, around any chimney breasts and a sample of internal walls with a Protimeter damp meter in conductance mode. Damp meters measure electrical conductance. Water is a poor electrical conductor. It is salts in water that conduct electricity. Despite criticism, damp meters are a good test of dryness. Protimeter readings below 20WME are considered dry. There were no high damp meter readings at the time of the survey..*

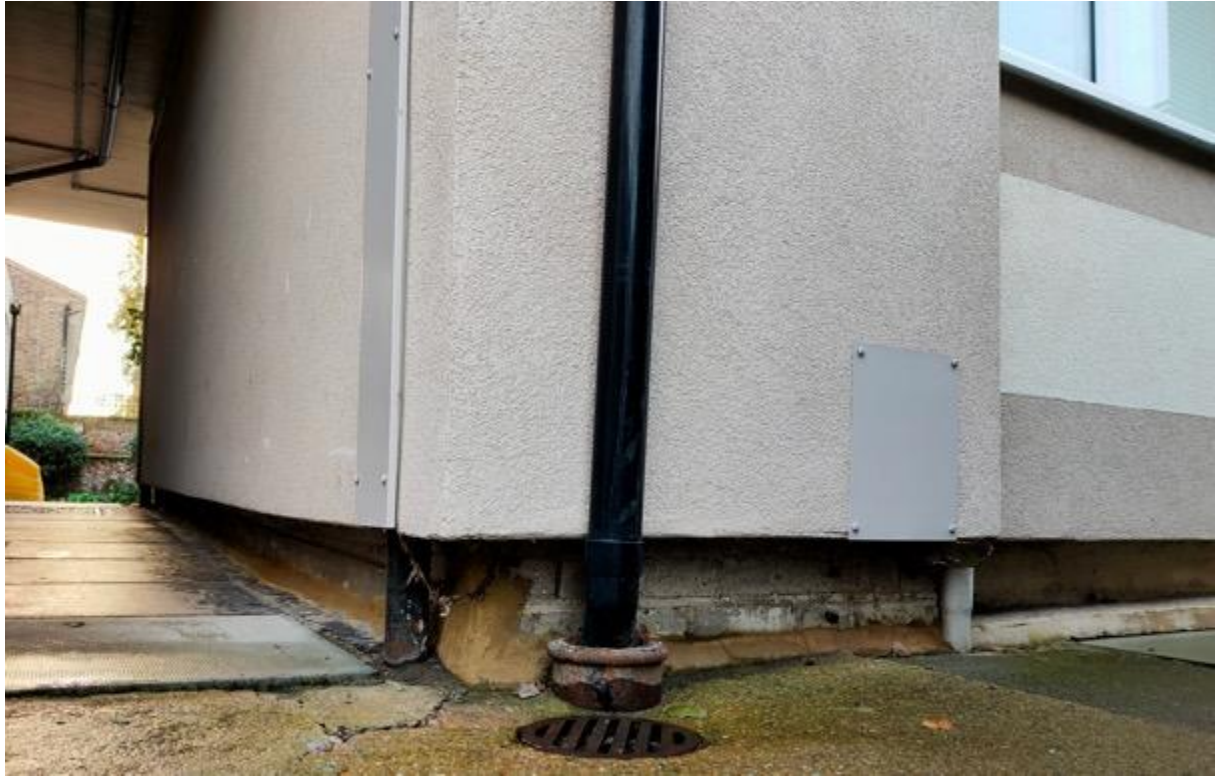
*Looking outside one can see the cause of dampness. The mould lines up with the base of the wall where the retrofitted insulation starts. The gap is a normal, but it causes a thermal imbalance*

**I consider if there is thermal imbalance** – I conclude; thermal imbalance is created by the external insulation reducing heat loss to all but a small area at the base of the wall and insufficient internal heating.

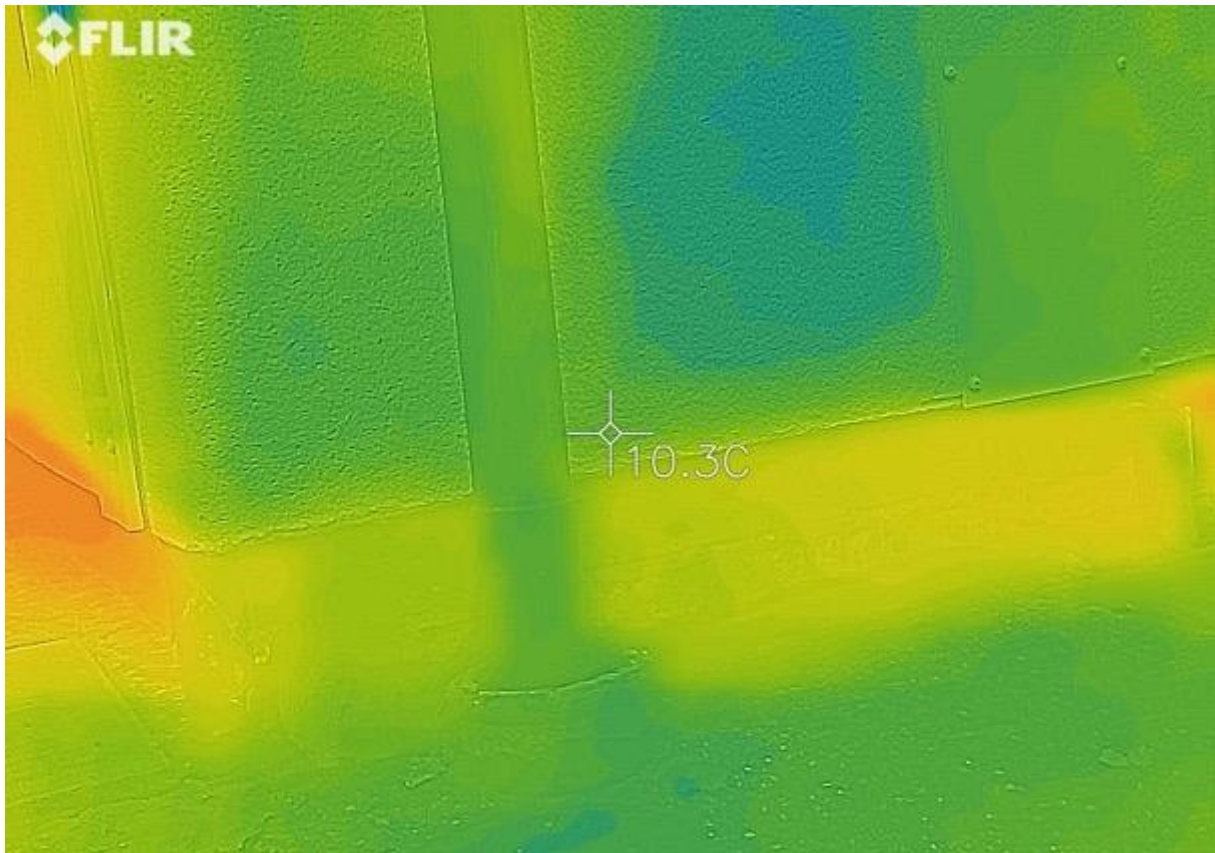
*Looking through a thermal imaging camera where blue is about 5°C colder than orange, we see that the base of the wall is slightly warmer on the outside. This warmth translates into heat loss on the inside. Some of the energy saving from the insulation should be used to improve ventilation, such as run the bathroom extractor fan for 30 minutes after taking a shower.*

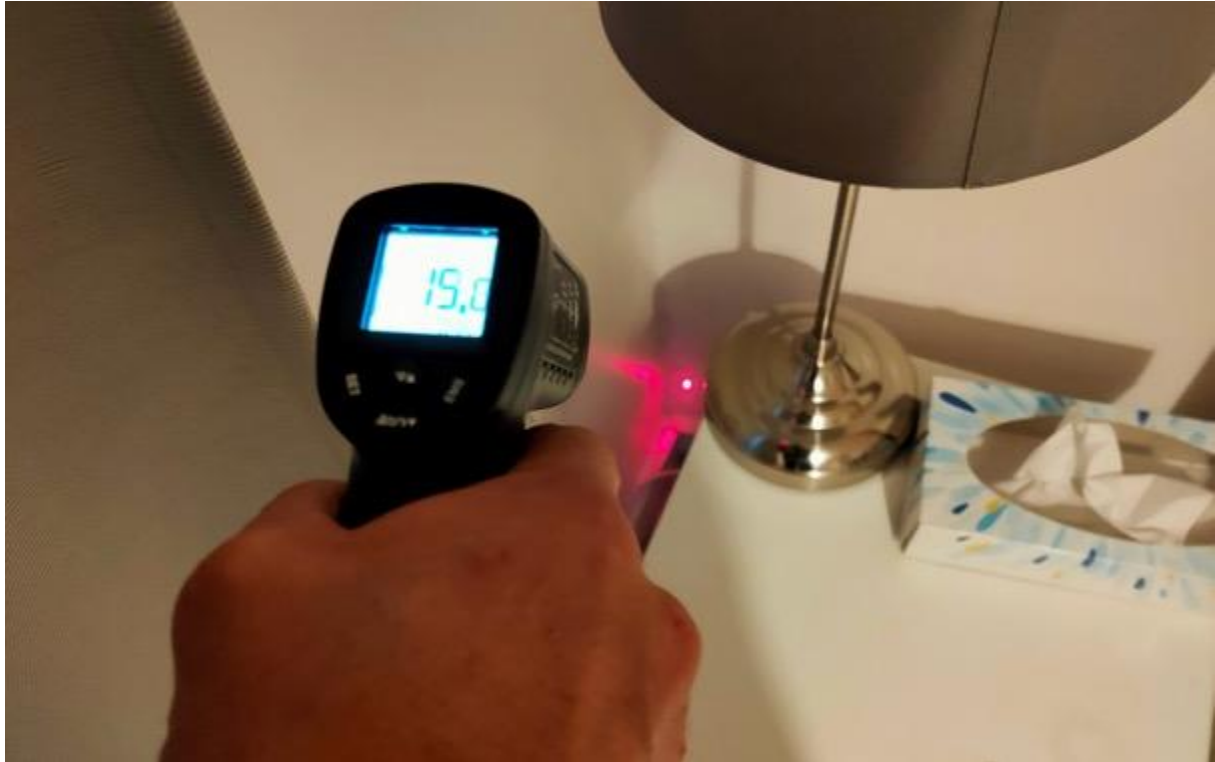
*The base of the wall measured 15°C. Taking the internal humidity measurement we can calculate a surface humidity of 81%RH. Mould only grows where relative humidity exceeds 85%RH for 6+ hours. Excessive humidity results from insufficient ventilation. Ventilation is most effective when air is extracted at the source of humidity; bathroom, kitchen, drying clothes and occupied room.*

Temperature of damp wall 15°C      Relative humidity of damp wall 81%RH

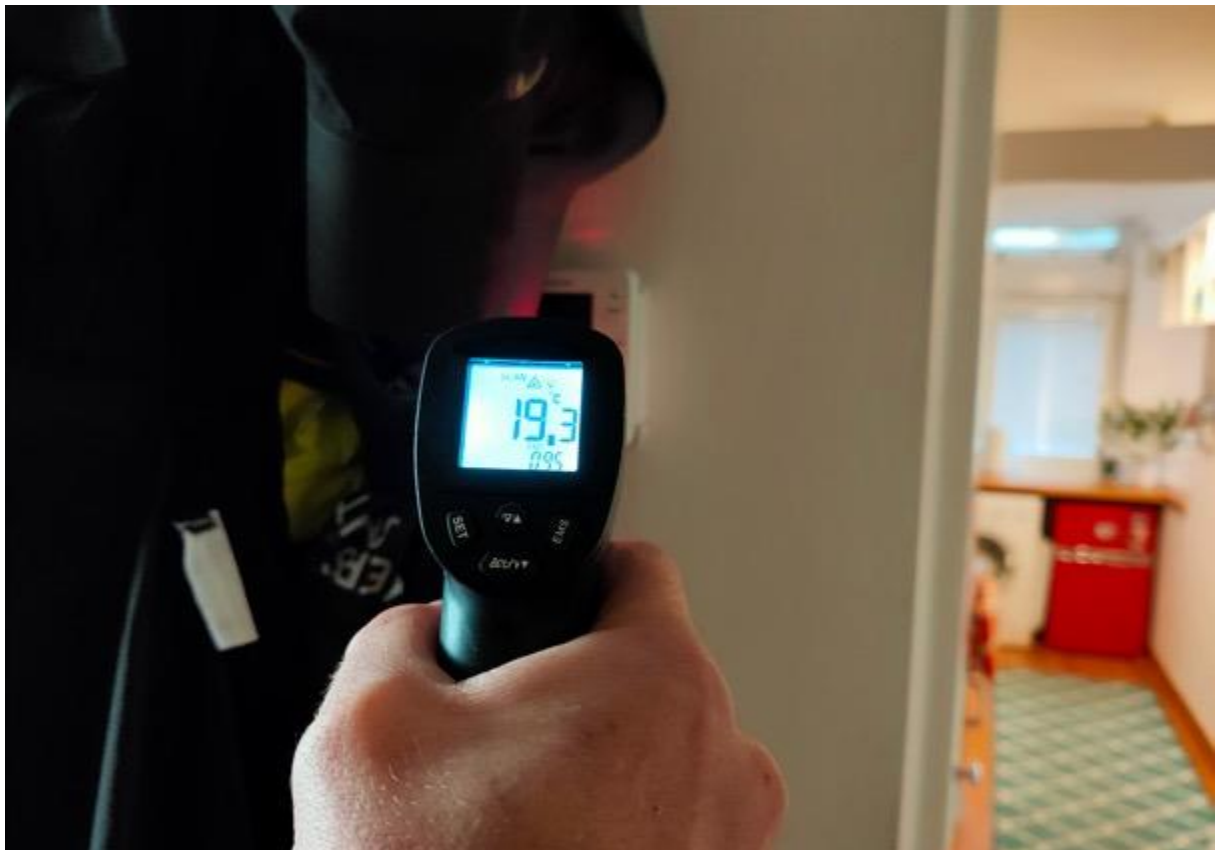
*By comparison the thermostat measures 19.3°C. So any thermostat setting should account for this imbalance.*

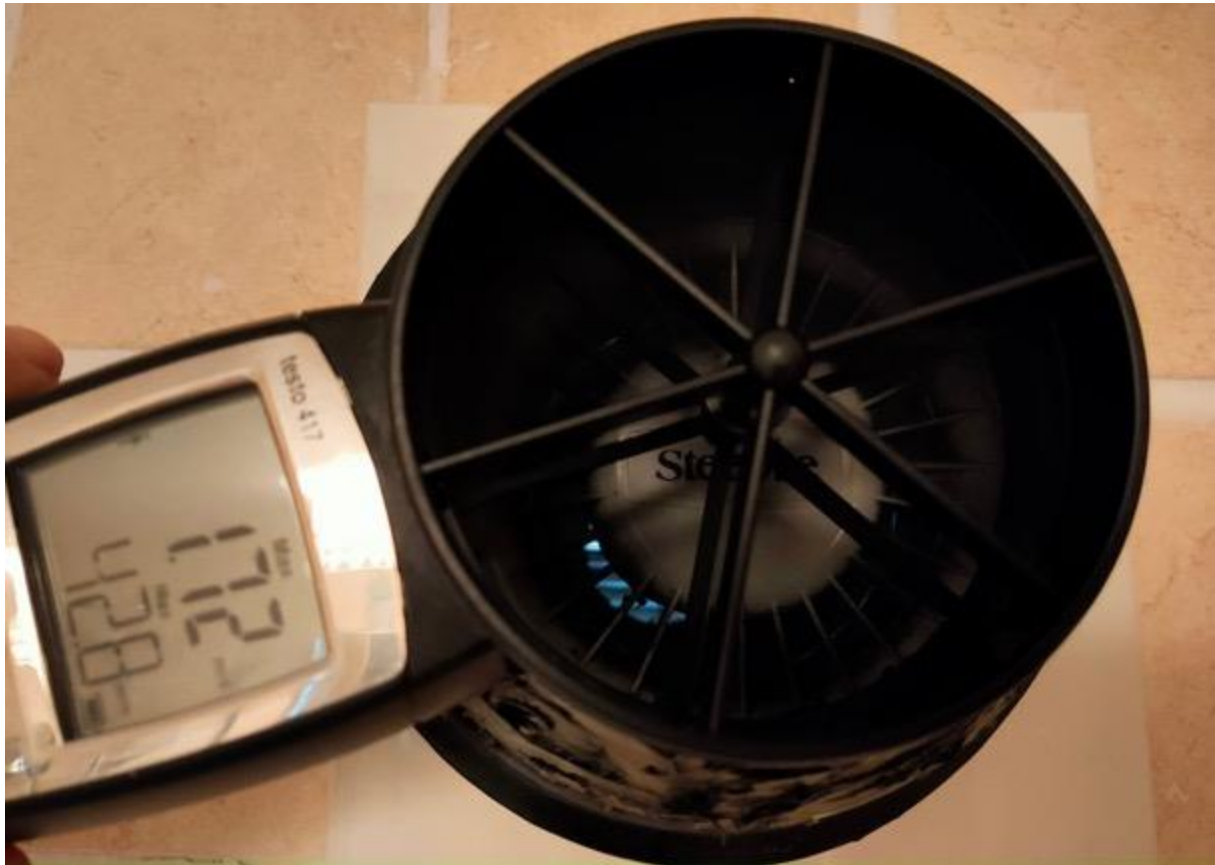
*The primary source of vapour comes from the bathroom. Here the extractor fan is manual. The speed was fast. However the extractor fan should be kept on for 30 minutes after showering with the door kept closed.*

**The bathroom extractor.** The extraction rate was **42.8 M<sup>3</sup>/min** (ideally it should be over **30 M<sup>3</sup>/min**). The extractor overrun was 0 minutes after the light was switched off. It should last for at least 20 minutes. The bathroom extraction rate is good. But it's needs to be kept in on for 30 minutes after taking a shower.

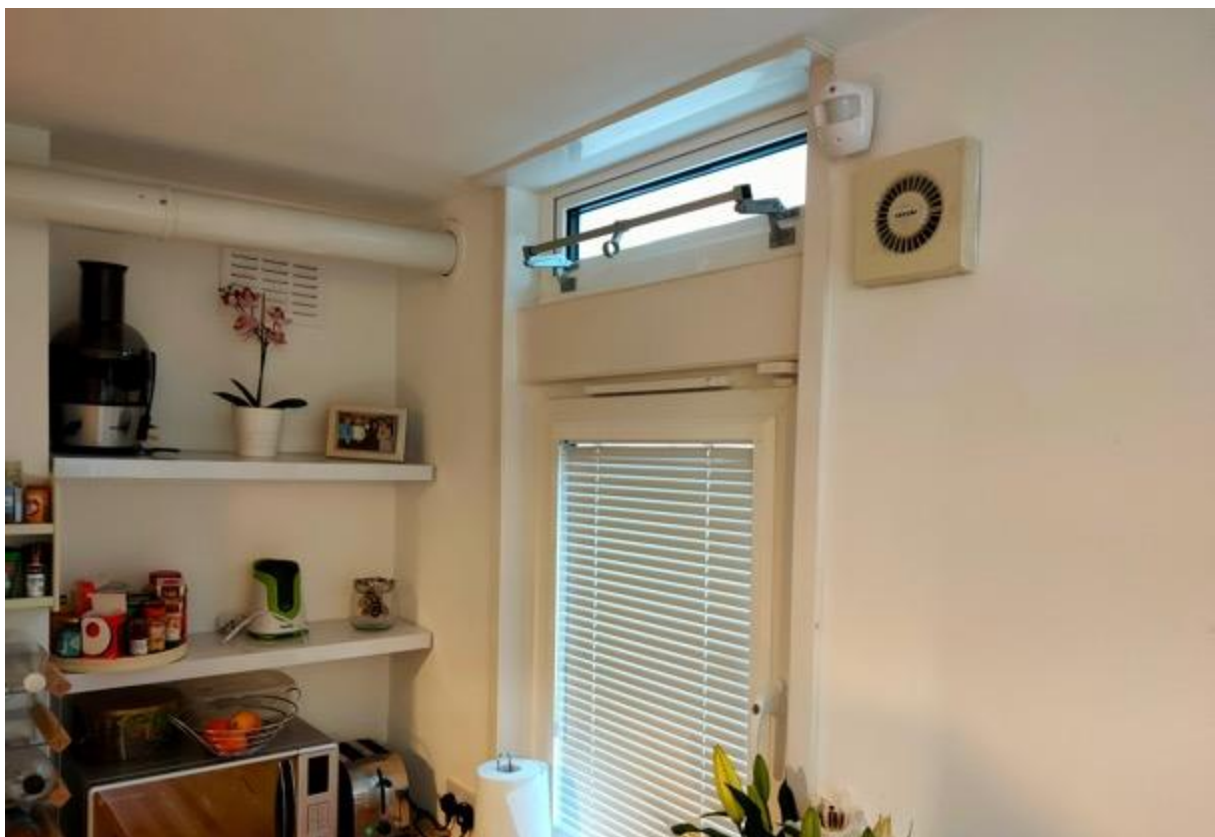
*There is an extractor fan in the kitchen, but is it being use? Another solution is cook with tops on pots and pans and any indoor drying of clothes should be in a vented room with the door closed.*

The extraction rate was 0 M<sup>3</sup>/min (ideally it should be over 100 M<sup>3</sup>/min).

I couldn't find switch to turn on kitchen extractor fan. The kitchen is open plan making it vulnerable to excess humidity.

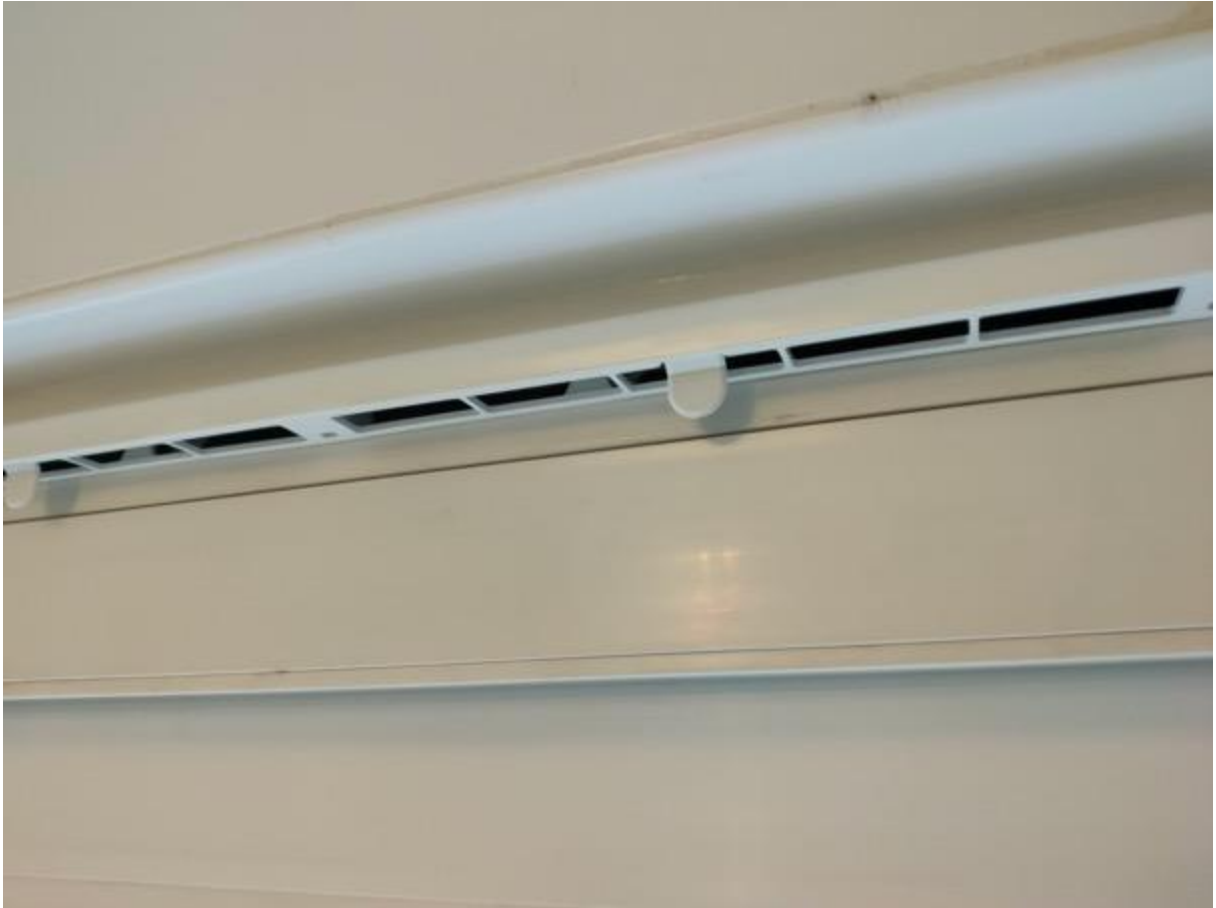
*Trickle vents were closed. I opened them during the survey.*

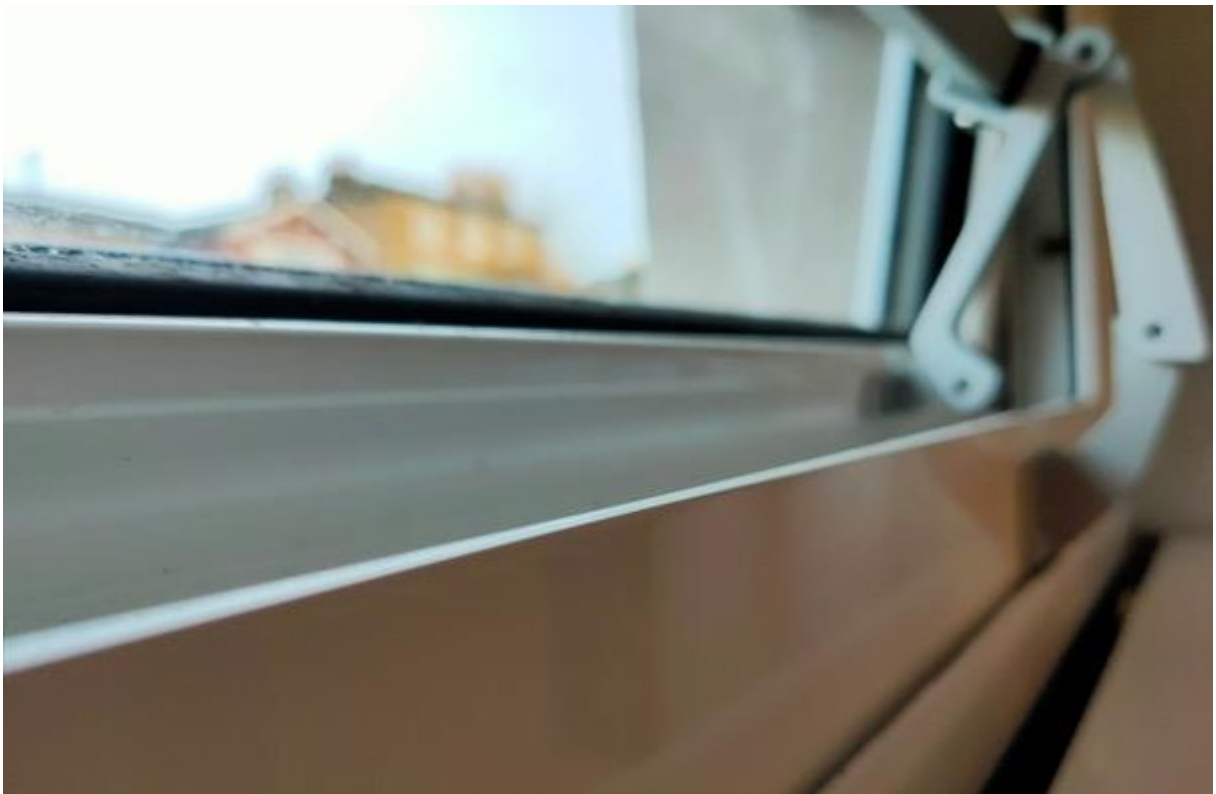
*There is also an option to open the small windows at the top to improve ventilation.*

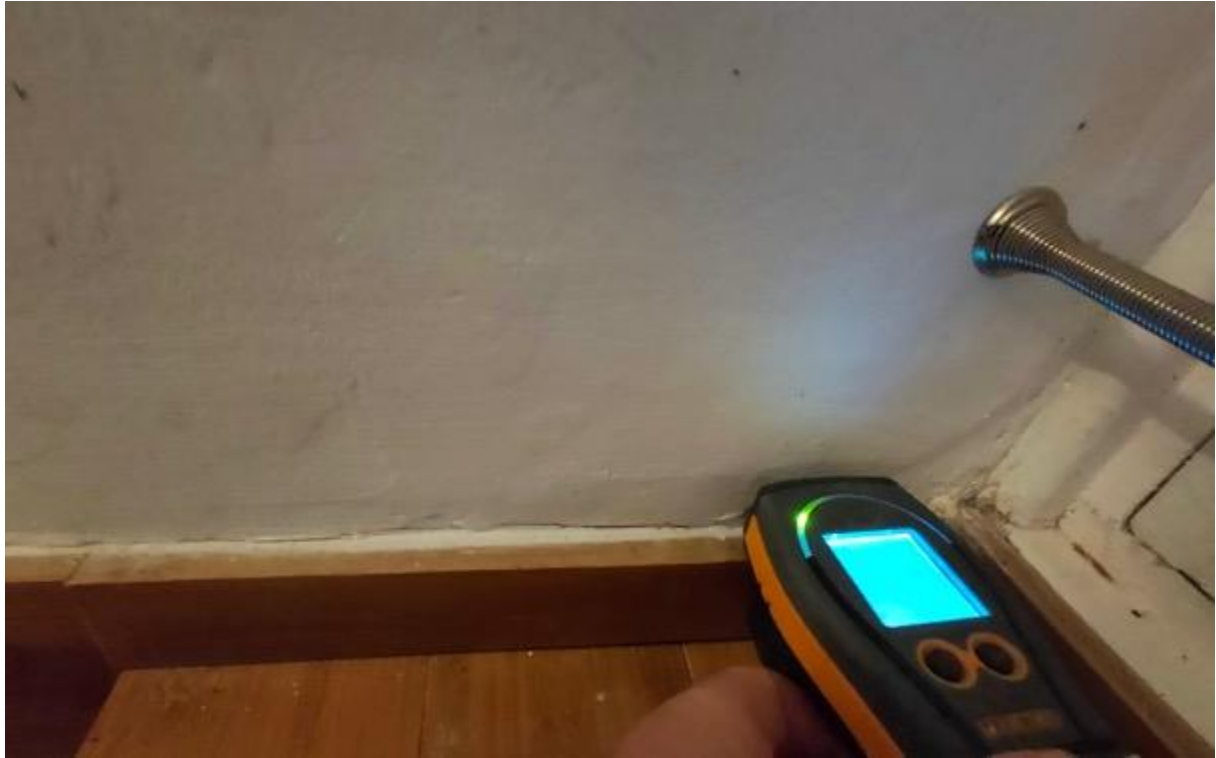
*We tested the inside of all external walls every 1M, the base of the walls by external entrances, chimney breasts and a sample of internal walls with a Protimeter damp meter in conductance mode. Damp meters measure electrical conductance. Water is a poor electrical conductor. It is salts in water that conduct electricity. Despite criticism, damp meters are a good test of dryness. Protimeter readings below 20WME are considered dry. All readings were low, below 20WME at the time of the survey. The above reading was taken by the front door.*

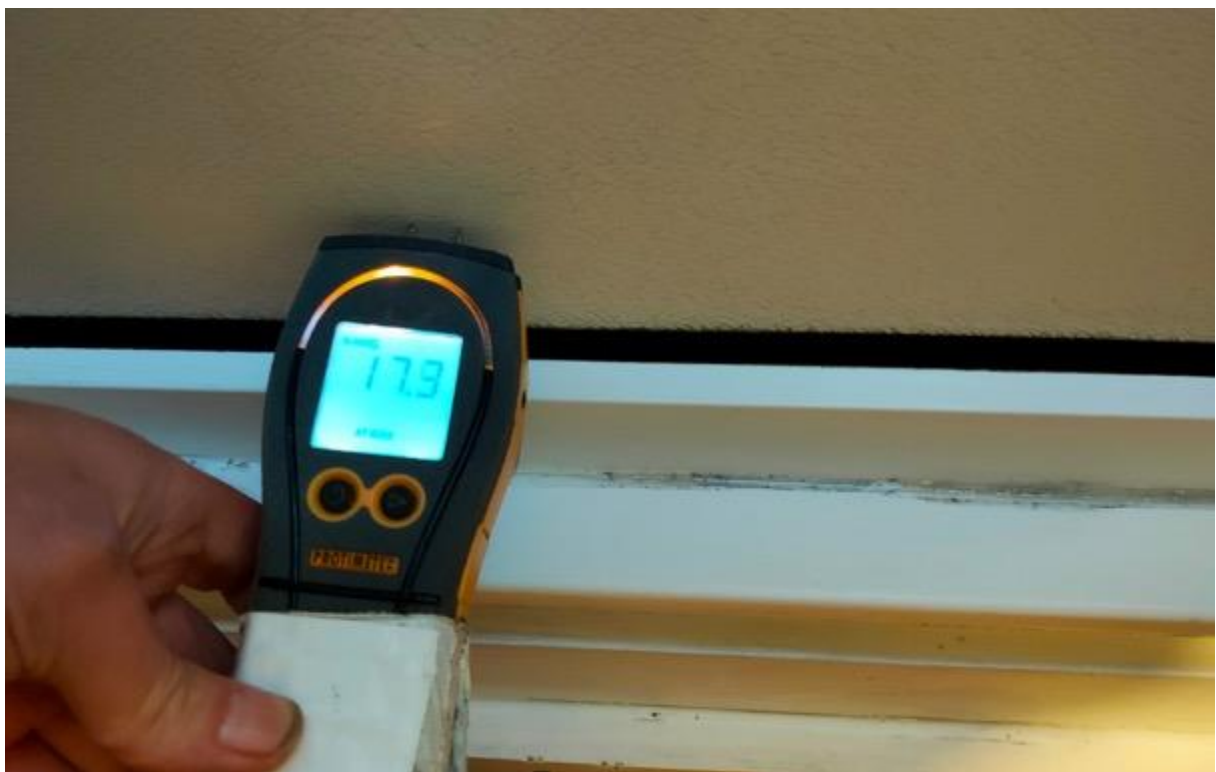
*The only marginally high reading was on the plastic section of wall below the window, caused by slight condensation. This panel could be insulated at virtually no cost.*
