EXAMPLE DAMP SURVEY
DAMP REPORT
for XXXX
2 February 2020

Report 10 February 2020

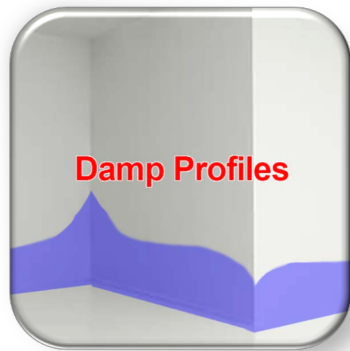
Symptoms of main issue: condensation.

Profile of main issue: Condensation profile

Visible effects: condensation, condensation was visible to the front corridor and around the property.
