REPORT

Property surveyed XXXX

Thank you for instructing us to carry out a damp survey of XXXX. We understand that you own the house. That your buyer's surveyor flagged up some potential damp issues and that you wish to have an opinion from an independent expert damp surveyor. Please inform us if we have misunderstanding your instructions.

I confirm that I inspected XXXX on 13 April 2018. I conclude that at the time of the survey there was no significant risk of rising damp from below the original external ground level.

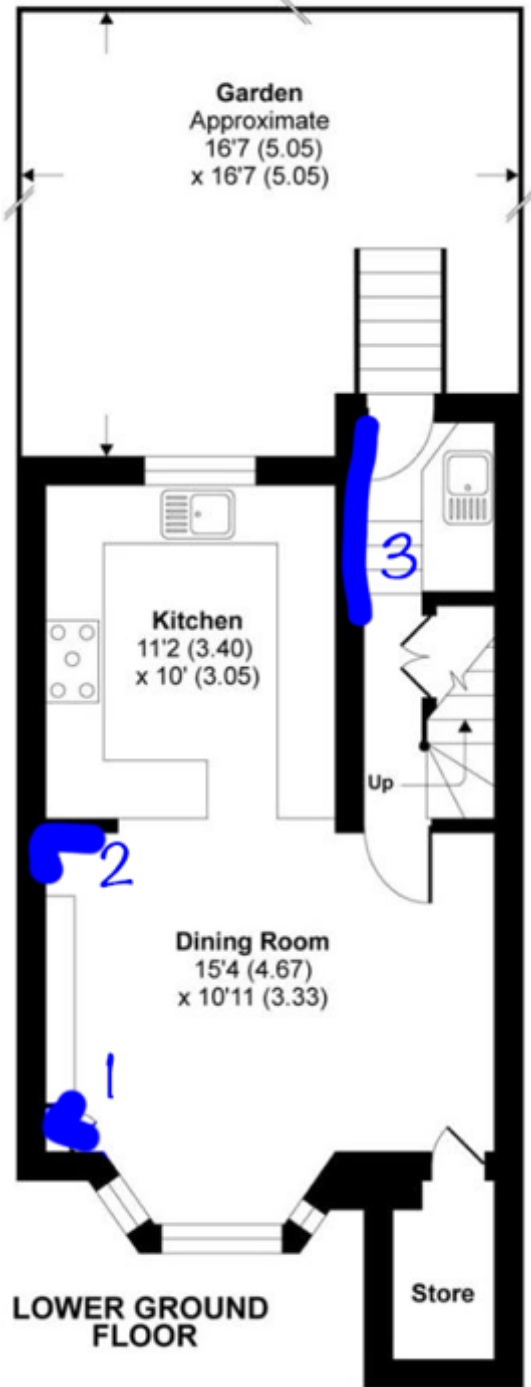
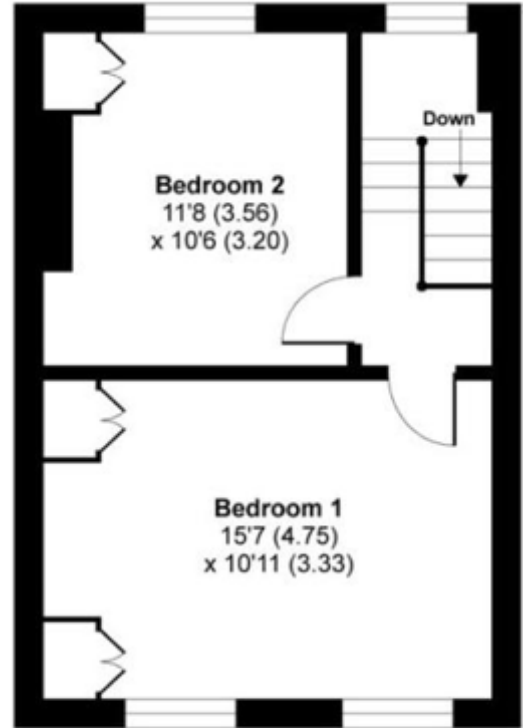
FIRST FLOOR

Elevated meter readings

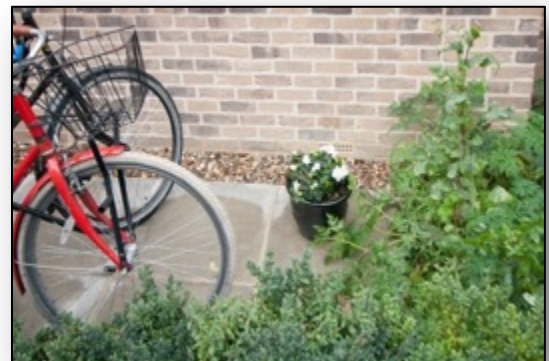
Exterior Ground Levels: The ground immediately surrounding a property is often raised by successive owners to the point where there is very little clearance between the ground and ventilation grills. In the worst cases water flows under the floorboards. Vents should be clear of the ground, ideally higher than a typical rain drop bounces, deemed to be 150mm.

The resolution is normally easy. A small trench (French drain) about 150mm, can be dug around the exterior walls, or vent and filled with shingle or similar material.
