REPORT

For and on behalf of XXXX,
Property surveyed

XXXX,
London, XXXX

Thank you for instructing us to carry out a damp and timber survey of the ground floor of XXXX. We understand that you own the flat. That your buyer's Homebuyers Report highlighted potential areas of damp. Please inform us if we have misunderstanding your instructions.

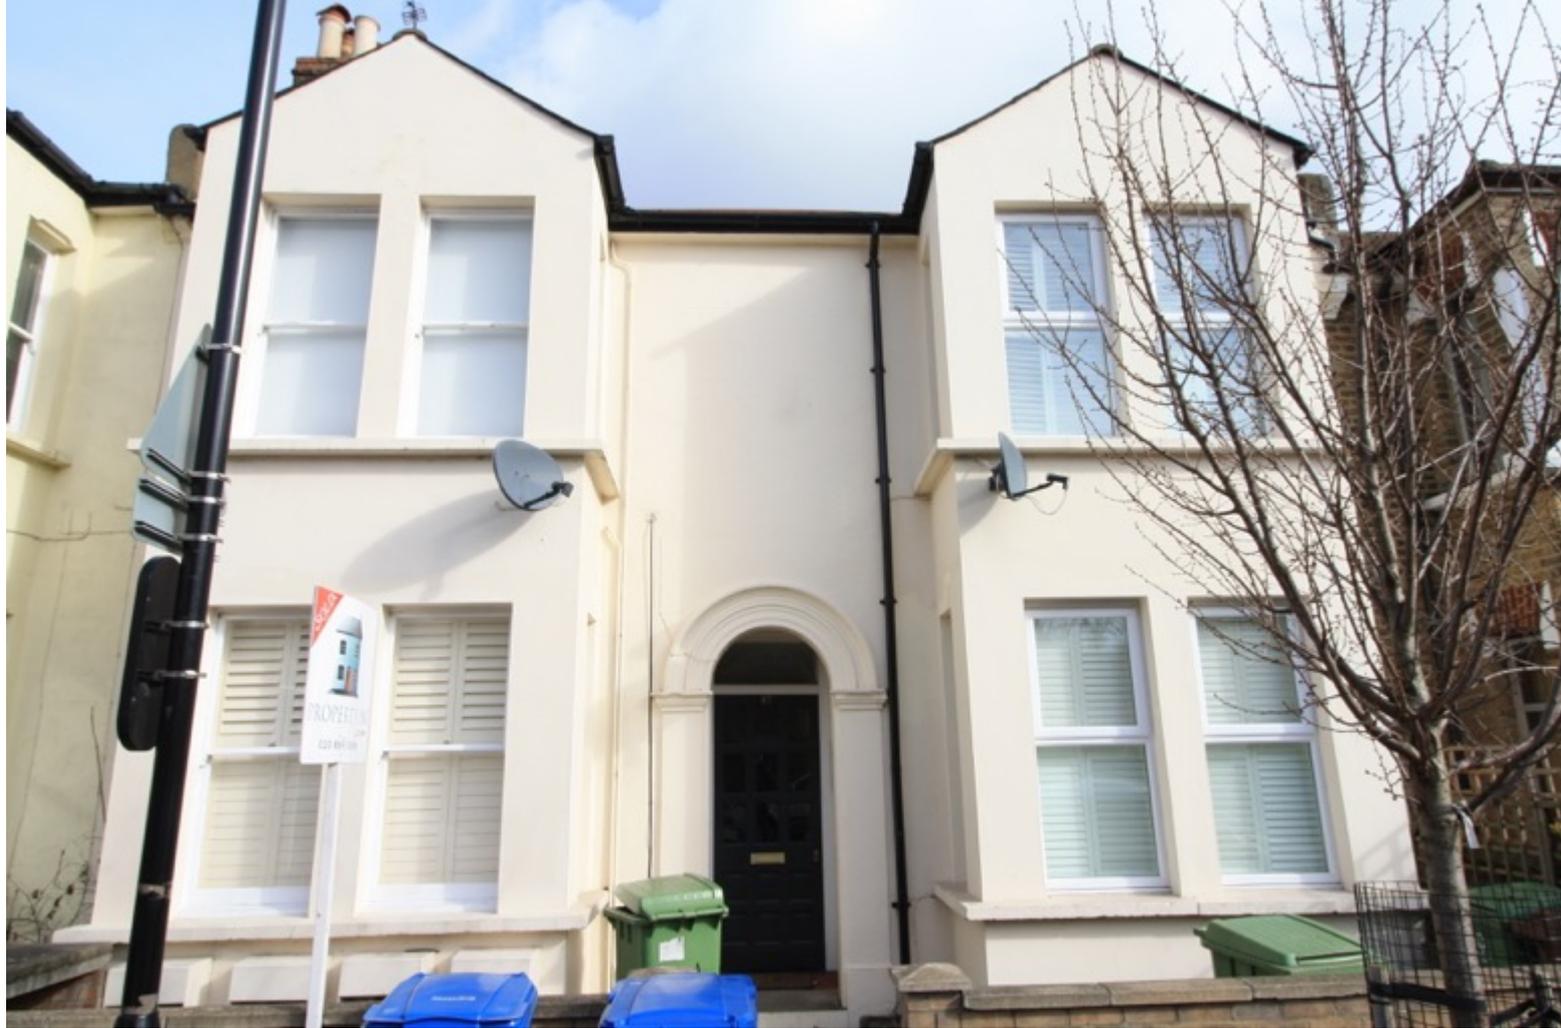
There tell-tale signs that a chemical damp proof course is already in place. The round ridges highlighted in the photo above, cover drill holes used to inject chemicals.

Chemical damp proof courses rarely address the cause of damp. In this case the cause of marginal dampness deep within the wall, is a blocked gully, which is inexpensive to fix.

We recommend you clear the blocked gully to the front and unblock the paint from sub-floor ventilation, also to the front.

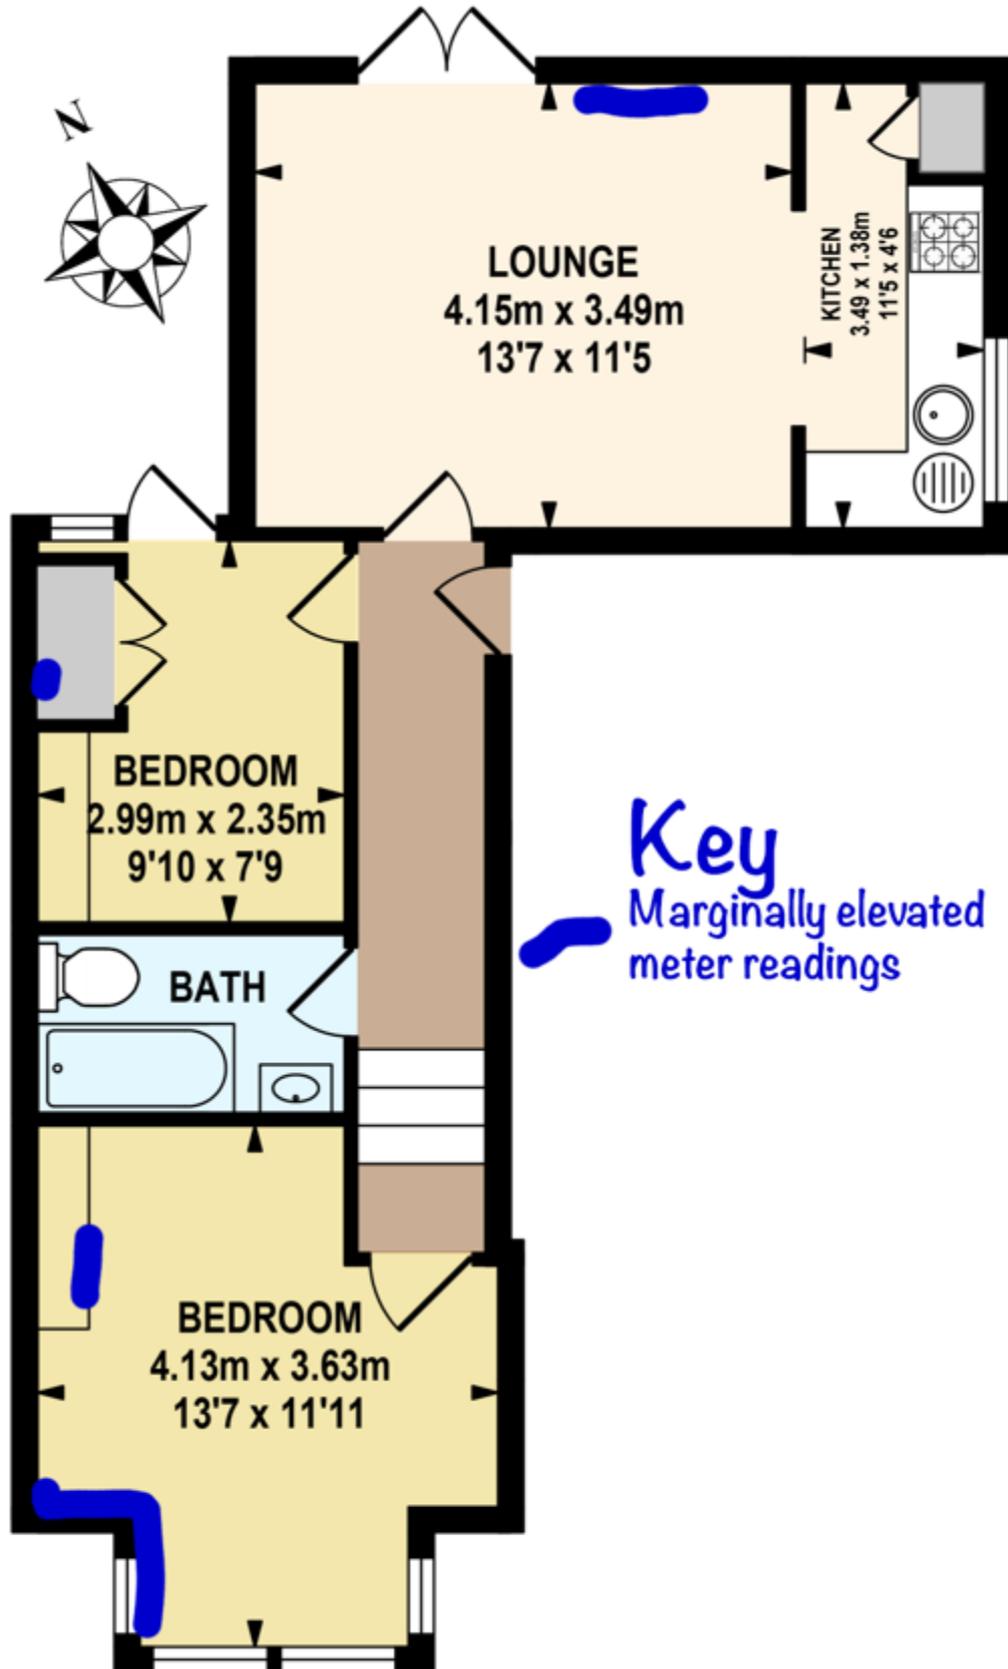
FLOORPLAN

For masonry, damp meter readings in conductance mode above 25% WME, need further investigation, see floorplan for details.
