*Ground floor apartment with a manual bathroom extractor fan and open plan kitchen with no obvious extractor switch. There is mould around the bathroom and bedroom and signs of condensation. The simple solution is to improve ventilation and heating balance.*

**HOMEBUYERS DAMP & TIMBER REPORT**  
for XXXX  
4 November 2019

*The property is a ground floor flat. The front door faces west.*

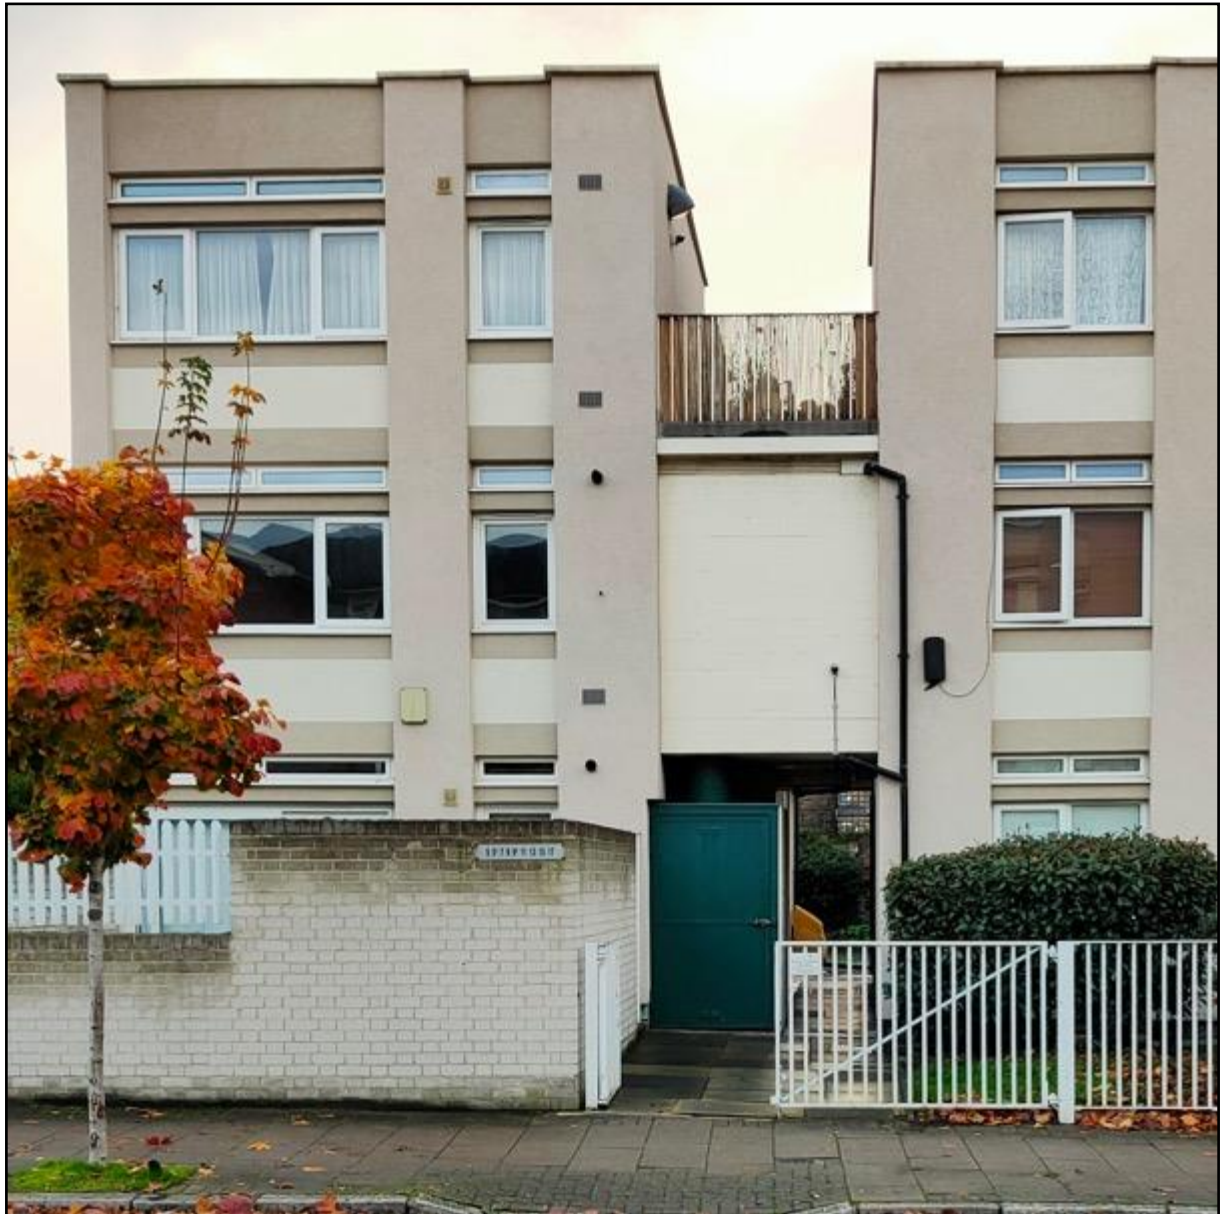
I confirm that I inspected Victoria Rise on 4 November 2019. I conclude that at the time of the survey that there was condensation and mould caused by excess humidity as a result of thermal imbalance and insufficient use of ventilation.

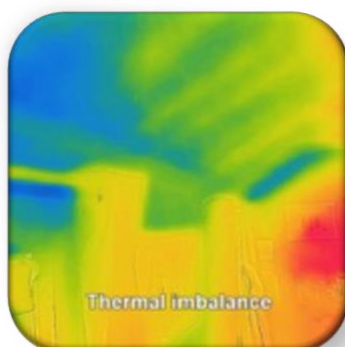
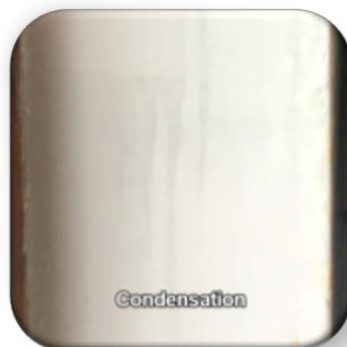
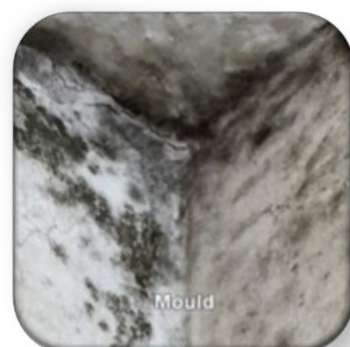
Relevant case studies; excess humidity (condensation caused by insufficient ventilation), excess humidity (mould caused by insufficient ventilation).
